20 December 2019

Project Number: 3611191238

**Subject: Vulnerability Assessment and Resilience Planning, Hamilton Wharf, Searsport, Maine  
Penobscot Bay Working Waterfront Resiliency Analysis  
State of Maine, Department of Marine Resources**

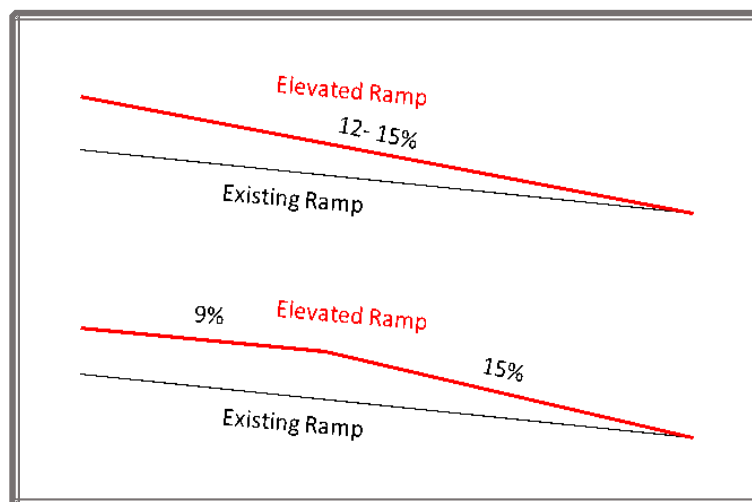
**Figure 2: Ramp Remediation Options**

We expect the boat ramp to remain operational during the Present Day and Short Term scenarios. During the Mid and Long Term scenarios, the MHHW levels increase to exceed elevations of the most preferred conditions of loading and unloading, between 2 ft and 5 ft (NAVD88). Due to rising water levels the ramp may become too deep to access during times of higher tides. During these periods, the accessible areas are sloped below the minimum recommended for boat ramps, creating undesirable conditions for loading and unloading.

- Recommend raising the ramp commensurate with the rising tide and providing the recommended slope between 12% and 15% (See **Figure 2** below). Depending on available space, options which incorporate varying slopes may be necessary to transition from the parking lot to the shore.

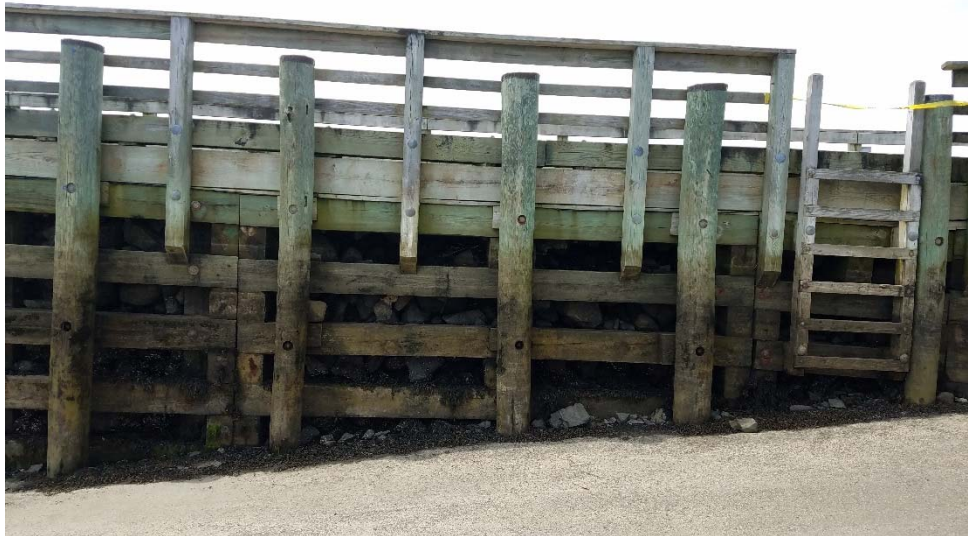
**Photograph No. 4:**

**View looking west at northeast side of wharf.**

**Construction of wharf noted as concrete deck on timber framing and piles.**

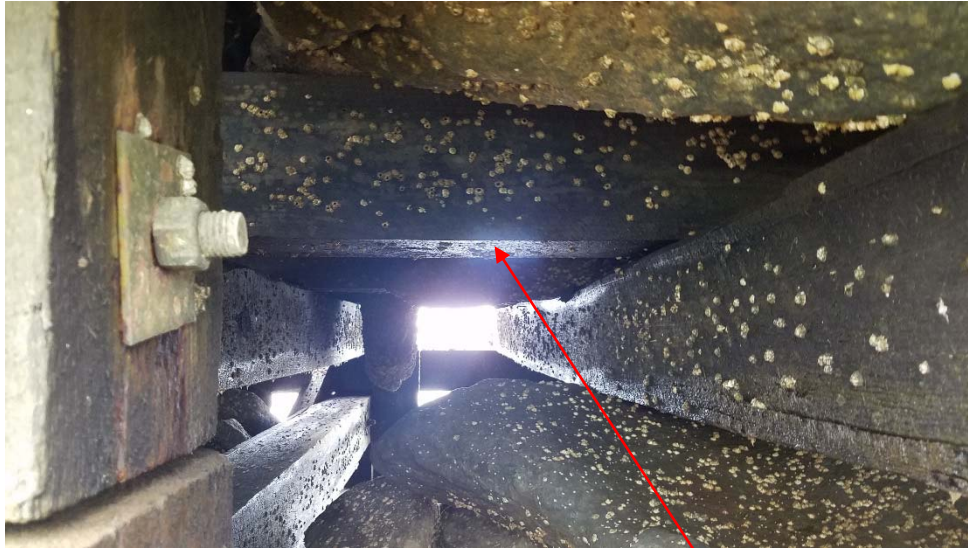
Photograph No. 9:

- 1. Indicates the presence of longitudinal framing. Member does not support the concrete deck.**

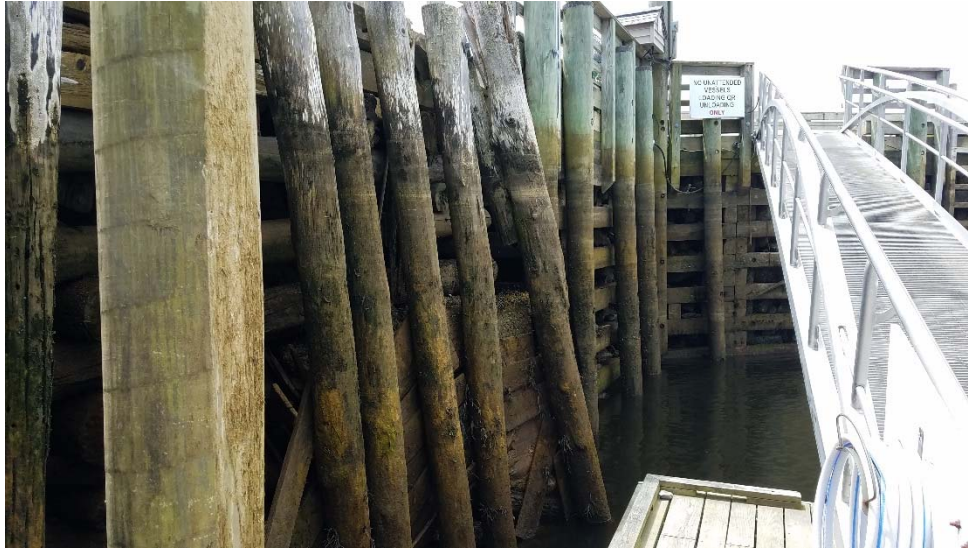
**Photograph No. 13:**

**View of north side of wharf Finger A.**

1. Deflection of timbers noted.

- Confirm positive attachment of all structural members to their substrate or load-bearing elements. Incorporate redundancies in design as needed based on a detailed structural analysis. Repair or replace damaged section designated as Finger A herein.
- Utilities and equipment should be properly secured to resist design wind and water loading or relocated above the flood elevation as specified in ASCE 24. Watertight enclosures should be incorporated for electrical equipment and conduits.

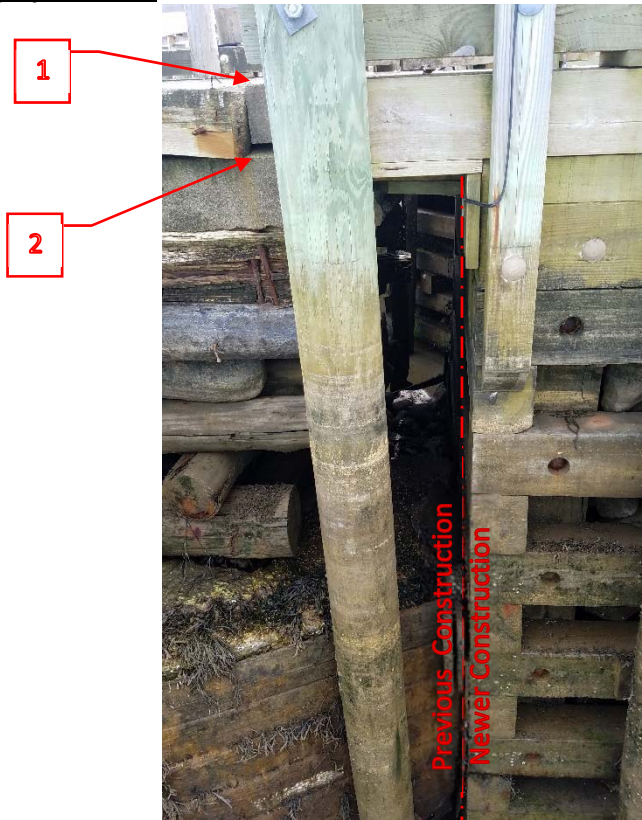
**Photograph No. 14:**

**View of apparent newer and previous construction at beginning of Finger A.**

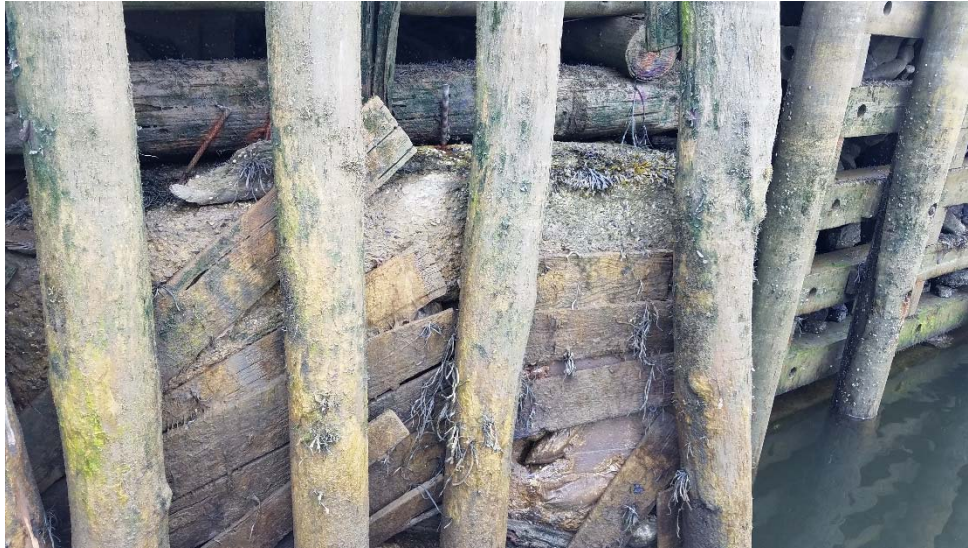
**Photograph No. 15:**

**Close-up of condition noted in previous photo.**

**System has begun to fail exhibiting extensive deflection and breaching of supplementary support.**

**Listing and leaning noted at adjacent piles.**

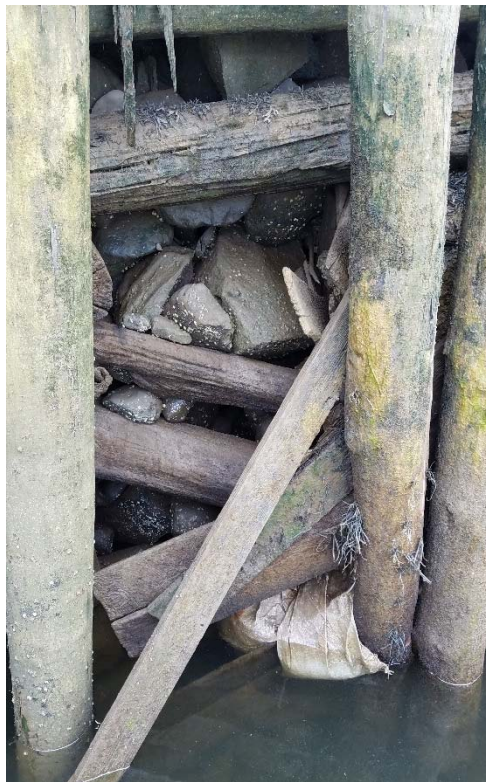
**Photograph No. 16:**

**View of possible breach allowing material to settle beneath the wharf deck above.**

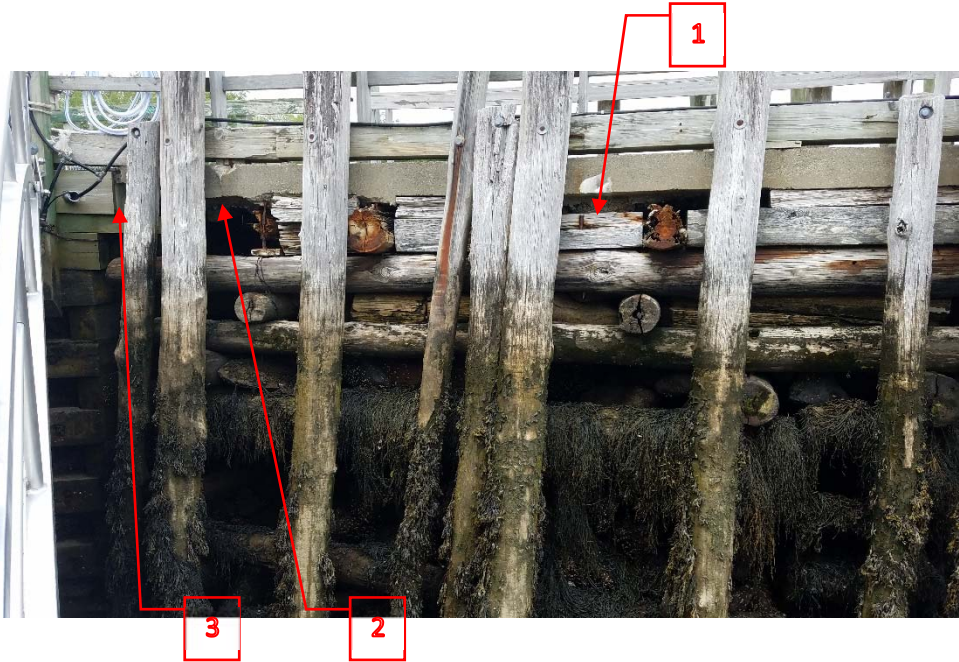
**Photograph No. 17:**

**View of south side of wharf Finger A.**

1. Weathered timbers which appear to support the concrete deck noted.
2. A through crack in concrete section noted at location of minimal support.
3. Location of concrete joint.

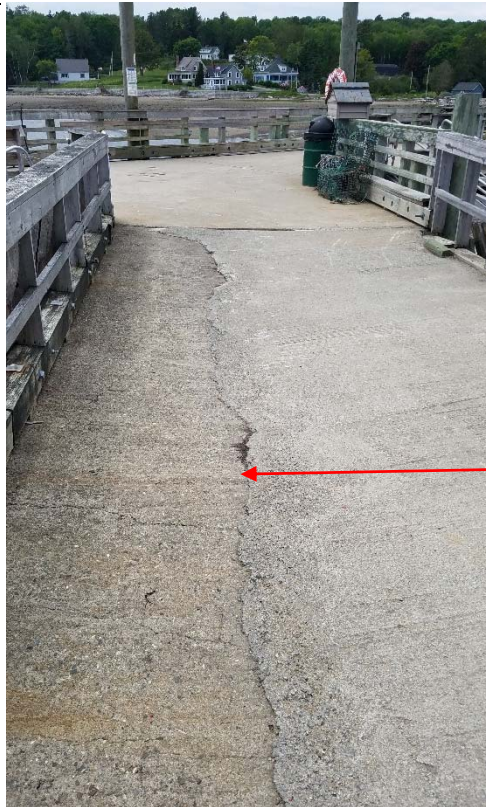
**Photograph No. 19:**

Similar view of deflecting concrete deck looking west on Finger A.

1. Cold joint noted in previous photo.

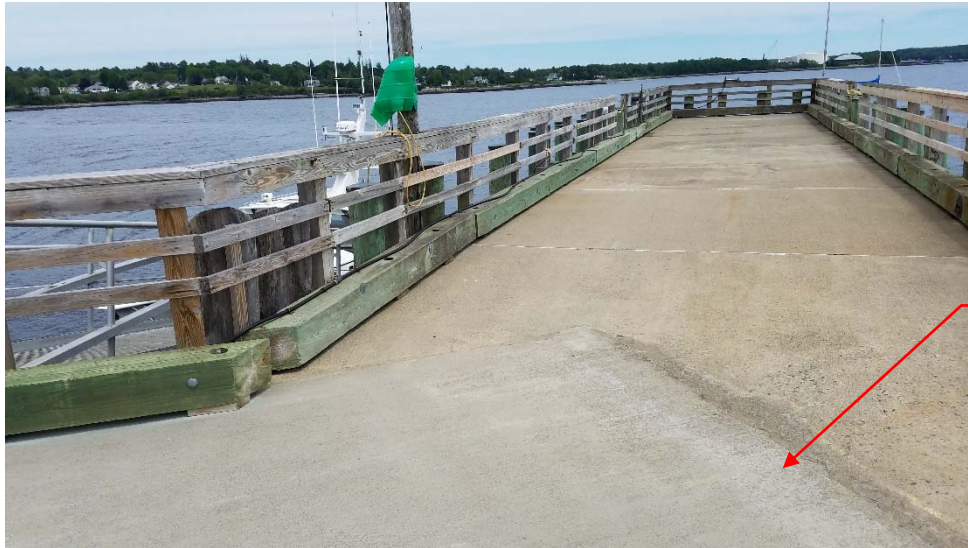
**Photograph No. 23:**

View of Finger B from above.  
View of cold joint adjoining Finger B to latest renovated main section of wharf.

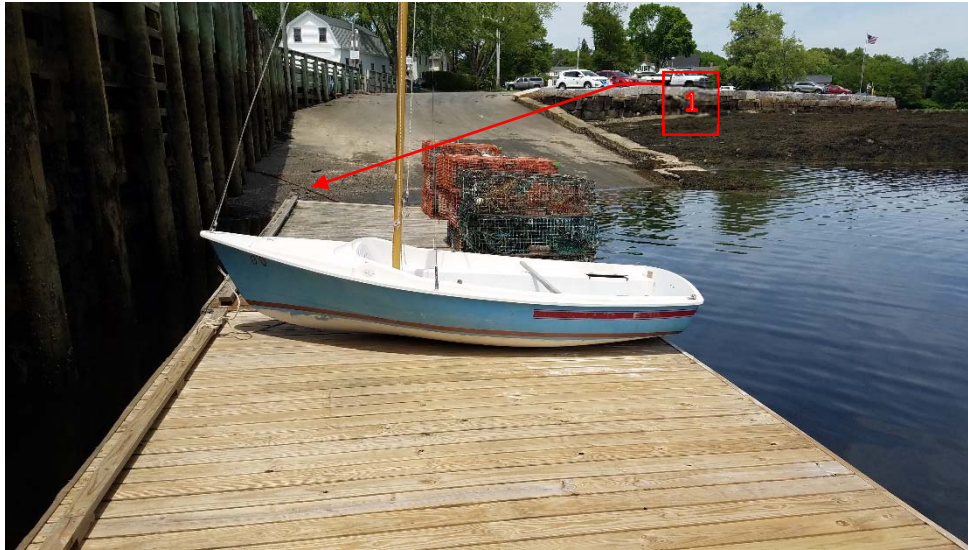
**Photograph No. 25:**

**View of Floating Dock 1 and boat ramp. This dock is not provided access with a gangway.**

- 1. Indicates chain used to secure dock to wharf.**

- Moor all floats to independent float piles or using mooring chains/ropes anchored to the seabed.
- Clean and coat all corroded steel framing members and replace corroded hardware. Confirm that all members are positively connected and the substrate is reasonable condition to resist the intended design loading
- Confirm the gangway attachments are sufficient to resist the design loading and repair or replace as needed.

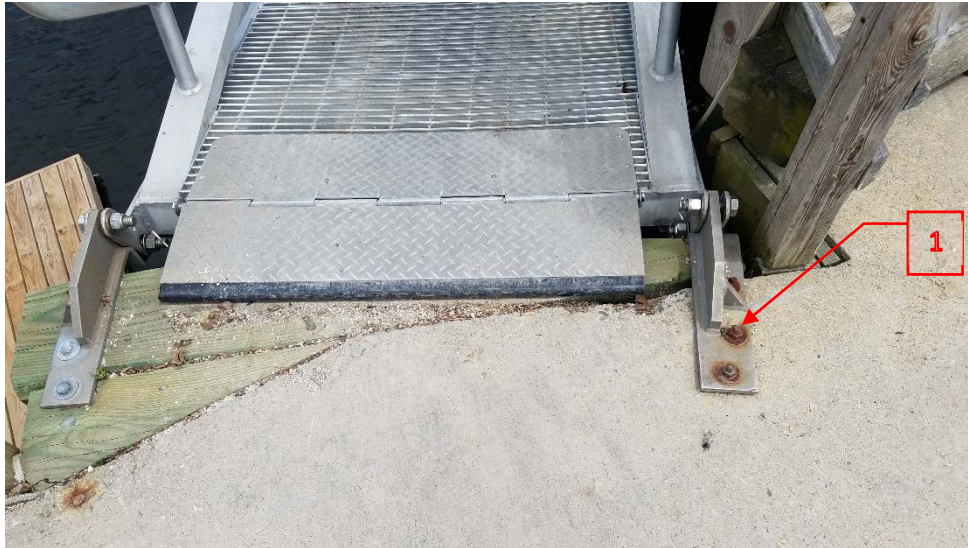
**Photograph No. 27:**

**View of connection for gangway to Floating Dock 2.**

- 1. Corroded anchors noted.**

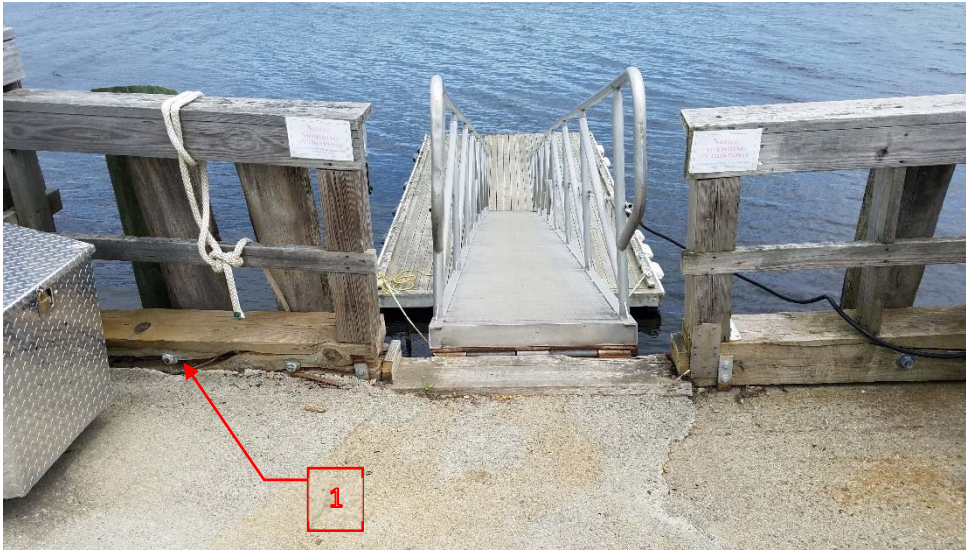
**Photograph No. 29:**

**View of gangway attachment to Finger A at wharf.**

- 1. Additional signs of deflection noted at curb connection**

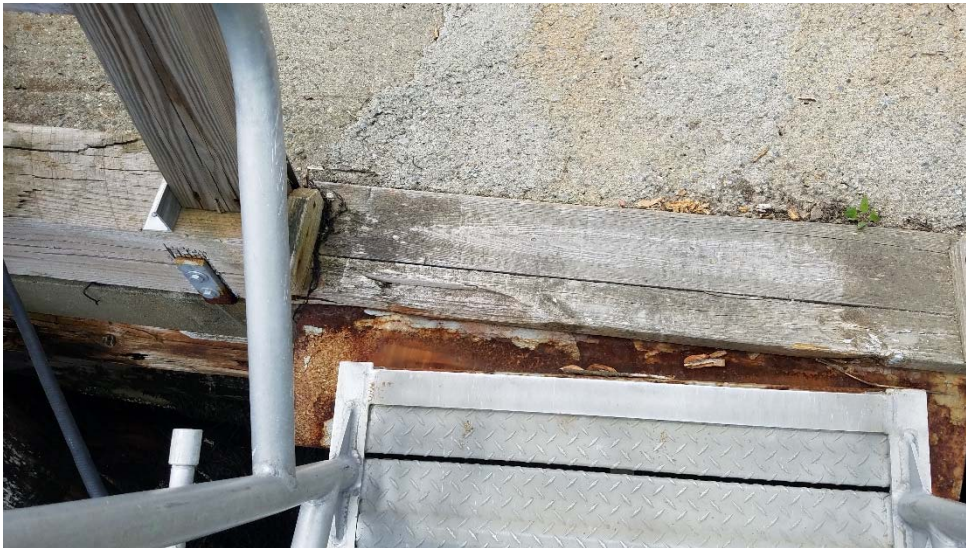
**Photograph No. 30:**

**Corrosion bleeding on adjacent structural members.**

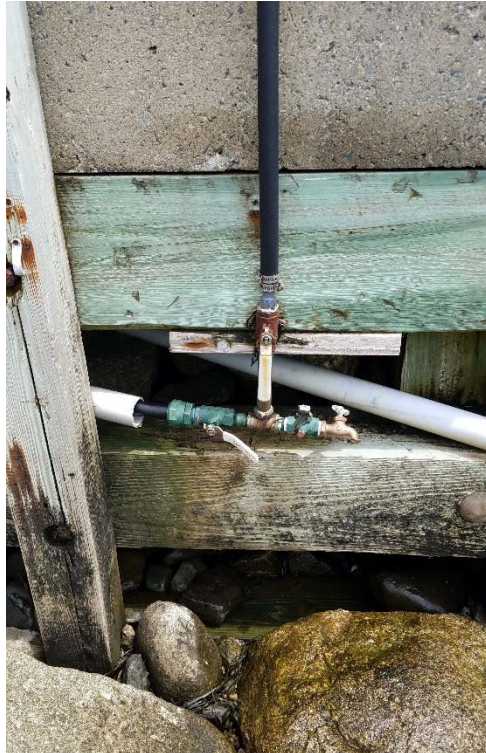
**Photograph No. 39:**

**Water fittings observed with signs of corrosion near entrance of wharf.**

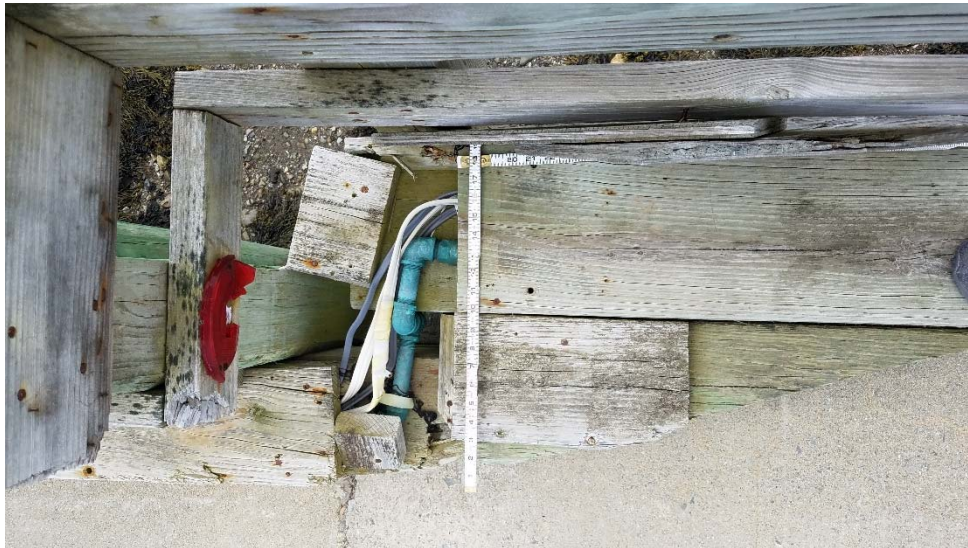
**Photograph No. 40:**

**Water supply line visible through opening in the wharf deck.**

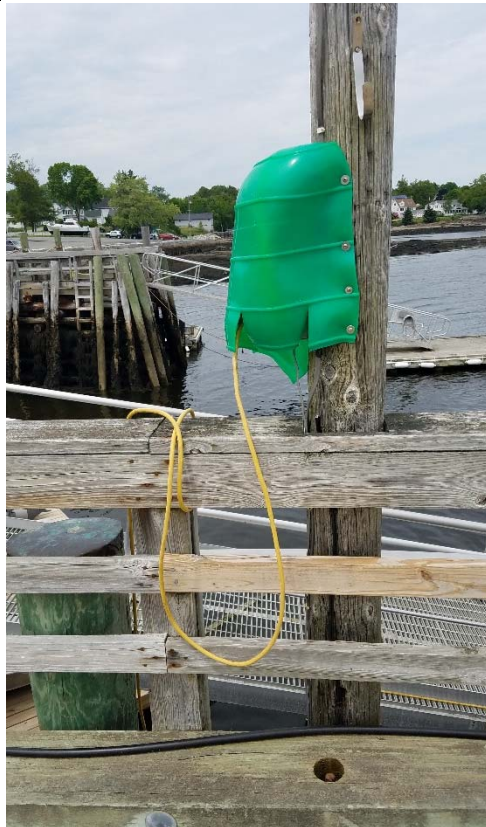
**Photograph No. 41:**

**Electrical fixtures at wharf finger 2.**

**Fixtures appear to be shielded from splash.**

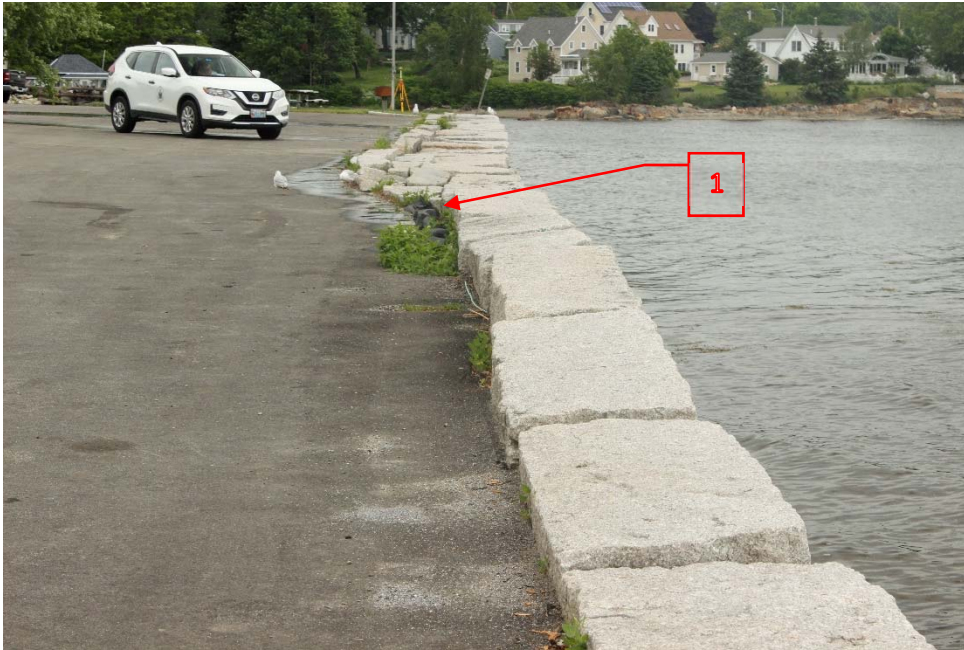
**Photograph No. 47:**

Shoreline protection exists in the form of a seawall, which essentially protects the parking lot and boat ramp from erosion. During our site visit, water levels were near the top of the seawall (Elevation 7.38 ft) which is consistent with previous observations by Town officials. Our analysis indicates that the Stillwater BFE would exceed the wall height for the Present Day scenario. There already appears to be concerns with the function of the wall for at least one location where seepage or piping was noted. Rock size appears to be sufficient, however improper subgrade material and poor compaction may be the cause of the settlement issue.

**View of seawall during elevated tide.**

- 1. Location of eroded pavement behind wall.**
