20 December 2019

Project Number: 3611191238

**Subject: Vulnerability Assessment and Resilience Planning, Lobster Coop, Stonington, Maine
Penobscot Bay Working Waterfront Resiliency Analysis
State of Maine, Department of Marine Resources**

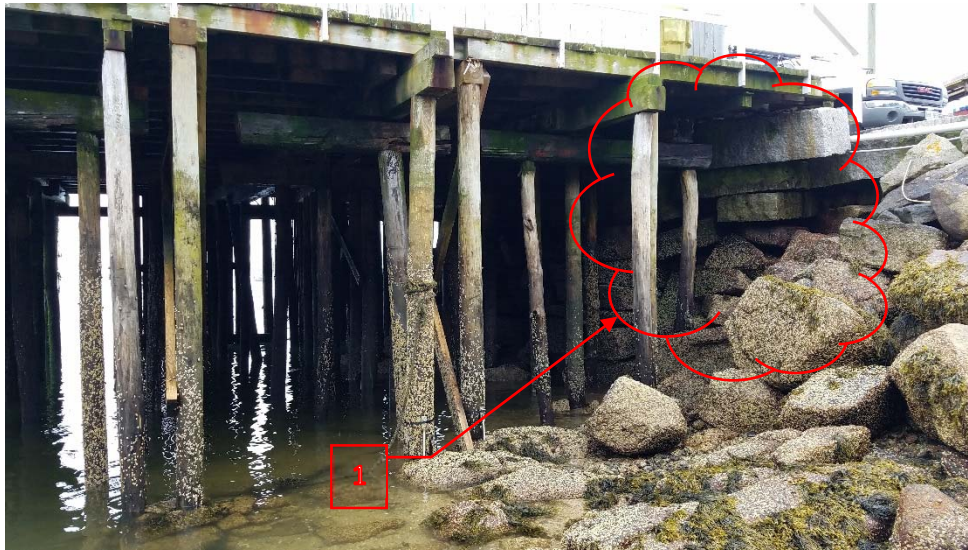
Photograph No. 5:

- Lack of stable gravity support at pier attachment to granite blocks (**Photographs 5, 6 & 15**) – bearing condition appears to be either deflected or not level. During closer inspection it appears that framing members are not attached such that they can provide lateral or uplift resistance.
- Lack of full lateral bracing (**Photographs 7-11 & 23**) – Lateral bracing was noted in only the north-south direction at one pier and no lateral bracing was noted for the other.
- Lack of blocking or bridging (**Photograph 12**) – Bridge or blocking between deck stringers were not present at locations observed.
- Moderate to major corrosion of fasteners (**Photographs 9, 10, 23**) – Exposed fastener reveals condition of progressive corrosion at exposed fastener in pier framing.

View of pier from north facing south.

1. Support of pier at granite blocks and piles.

- Confirm positive attachment of all structural members to their substrate or load-bearing elements. Incorporate redundancies in design as needed based on a detailed structural analysis. Provide additional lateral bracing throughout as battered piles and/or cross bracing in both directions. Verify adequate support for the above structures (Fish House, Fisherman's Office) is provided for lateral and gravity loading. Recommend an investigation to confirm the presence of decay, shipworms or marine borers and determine the need for corrective action for all above cases per a Structural Engineer licensed in the State of Maine.

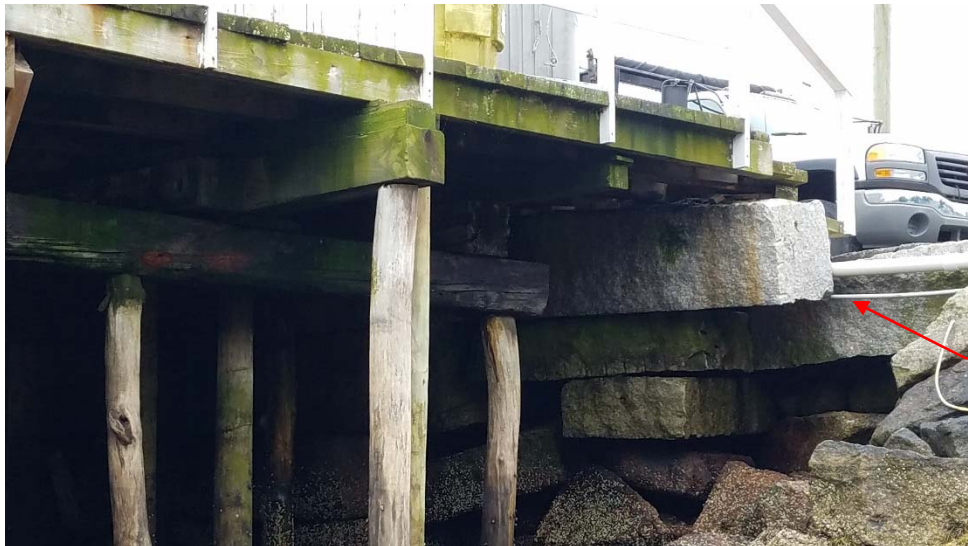
Photograph No. 6:

Close-up of condition in previous photograph.

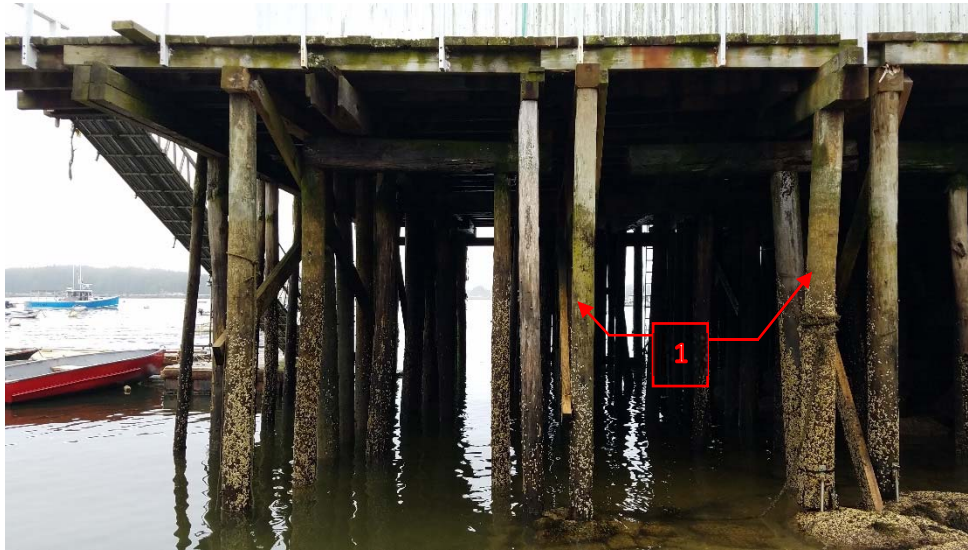
Photograph No. 7:

1% Stillwater elevation are above the deck, is dependent on structural elements being properly attached. In addition, we noted a lack of lateral bracing at the piles in the east-west direction for the entire pier and in both directions for one section of pile framing. Based on the type of construction and the total unbraced length of the piles above their embedment in the sea floor, we would expect bracing at regular intervals.

View of north side of pier facing south.

1. Typical pile layout. No lateral bracing in the east-west direction visible.

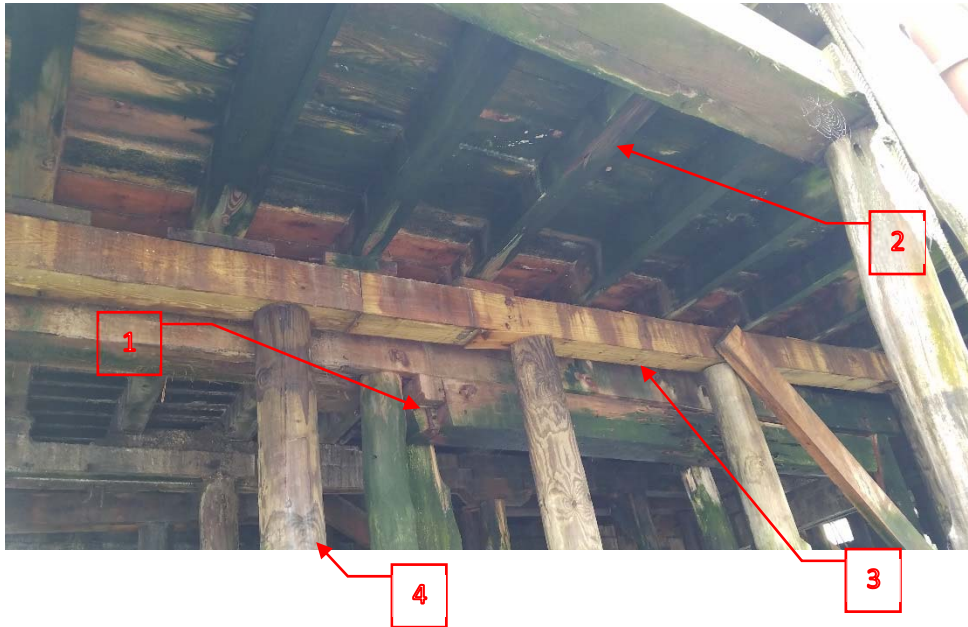
Photograph No. 9:

View at underside of deck. Pile caps and stringers visible. Signs of green algae and what appears to be white mold at underside of deck.

1. View of exposed fastener.
2. Typical Stringer
3. Pile Cap
4. Pile

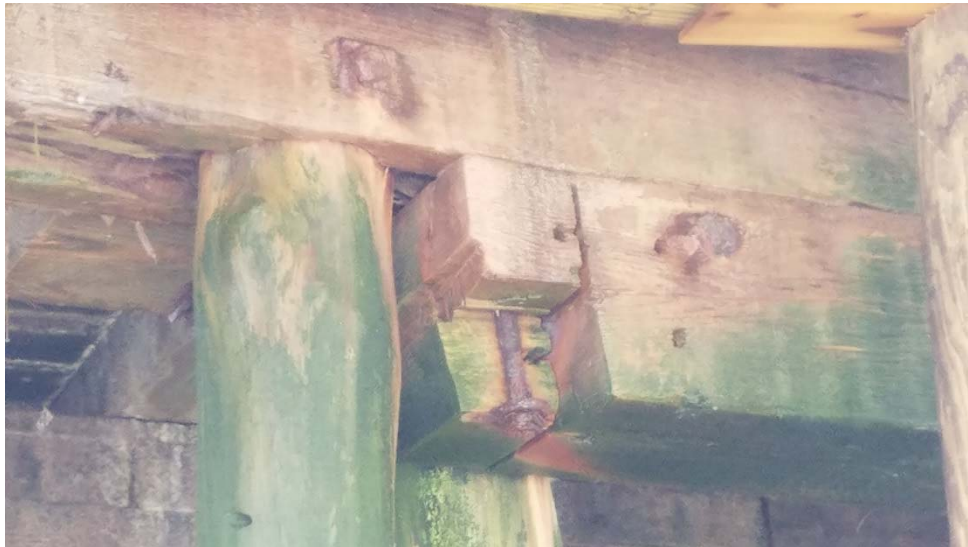
Photograph No. 10:

Close-up of condition noted in previous photograph.

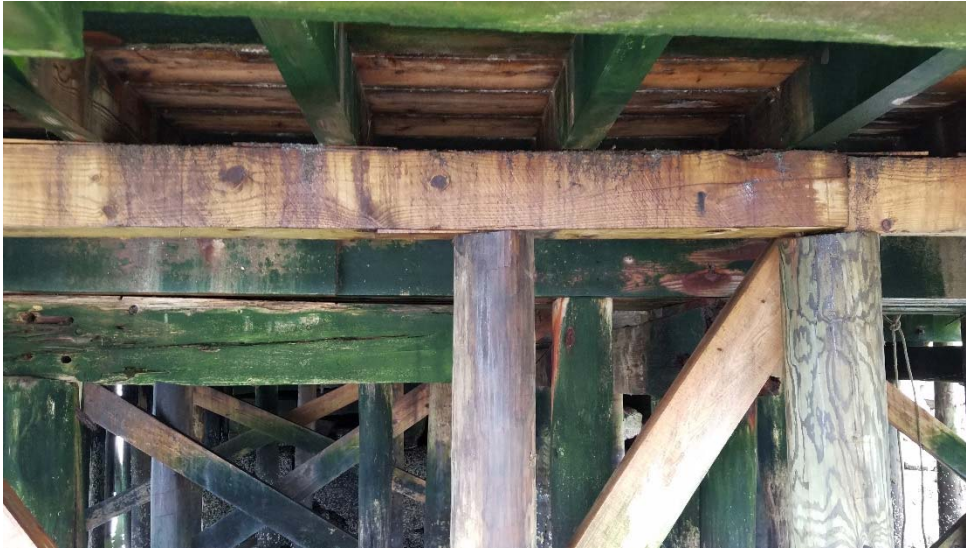
Photograph No. 11:

View of framing at underside of pier facing west.

No strap or other steel framing element noted.

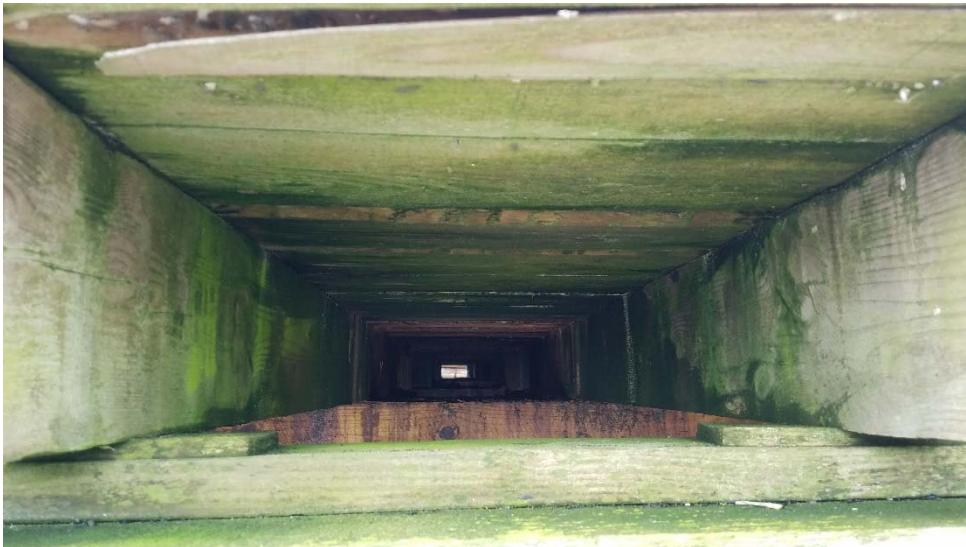
Photograph No. 12:

Typical view between stringers.

No bridging or blocking noted.

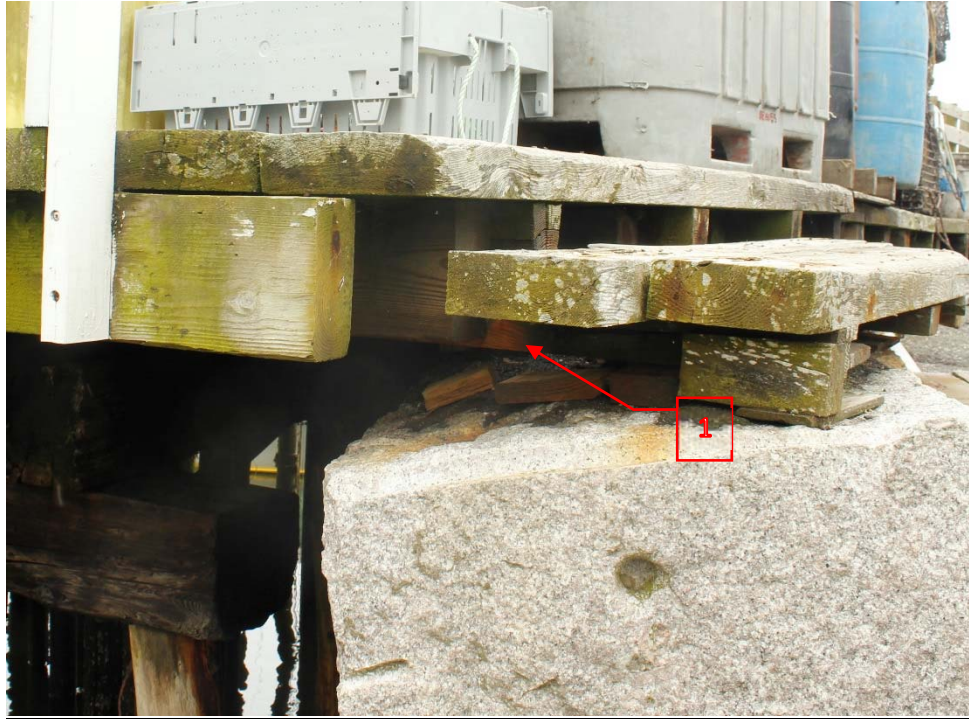
Photograph No. 15:

Closer view of pier support on granite block at wharf/grade.

- 1. Timber stringer bearing.**

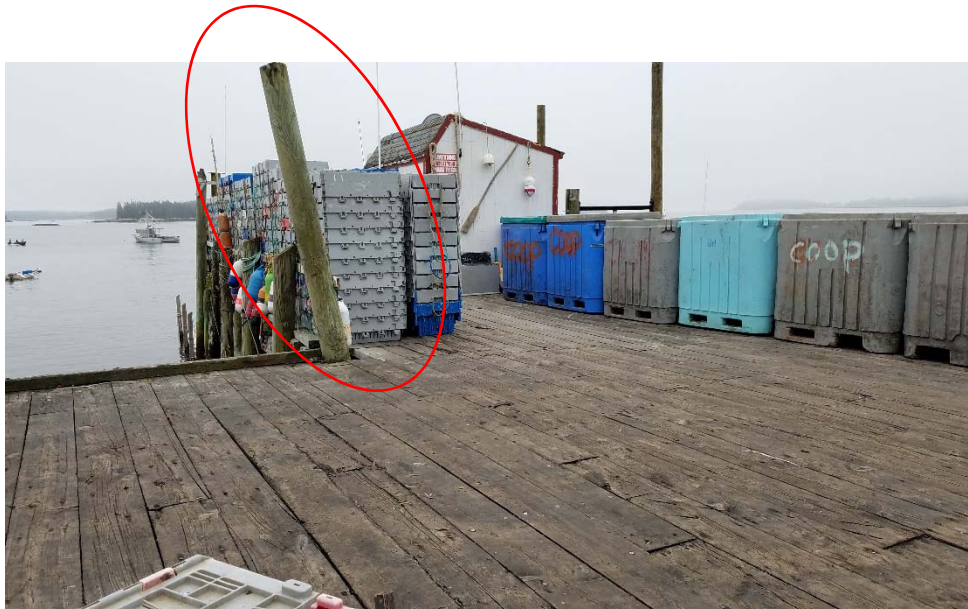
Photograph No. 17:

View of deck from above. Deteriorated members noted from wear. Pitting and surface delamination noted.

A battered pile noted at corner of deck.

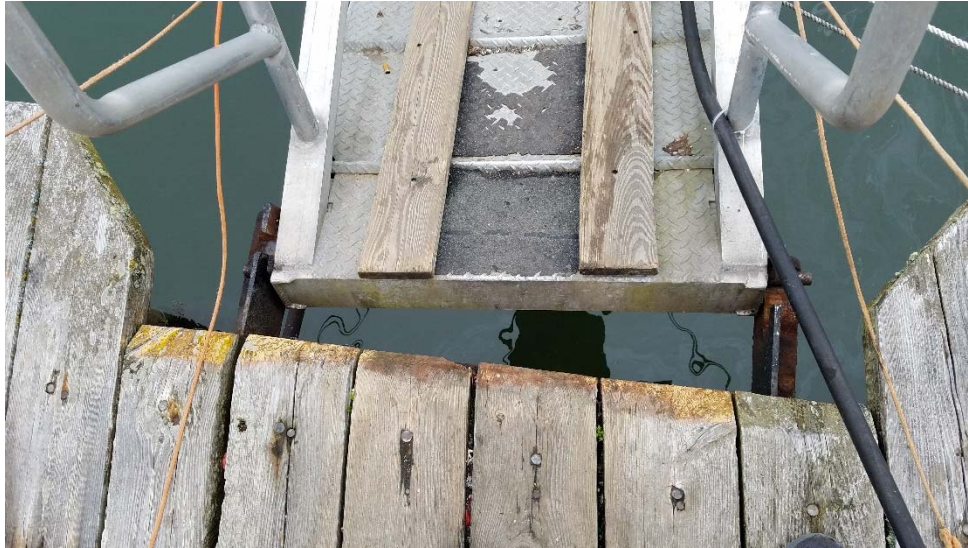
Photograph No. 21:

Close-up of gangway connection to pier.

Note misalignment of the gangway attachment. Need to monitor.

- Clean and coat all corroded steel framing members and replace corroded hardware. Confirm that all members are positively connected and the substrate is in decent condition to resist the intended design loading.
- Confirm the gangway attachments are sufficient to resist the design loading and repair or replace as needed.
- Moor all floats to independent float piles or using mooring chains/ropes anchored to the seabed.

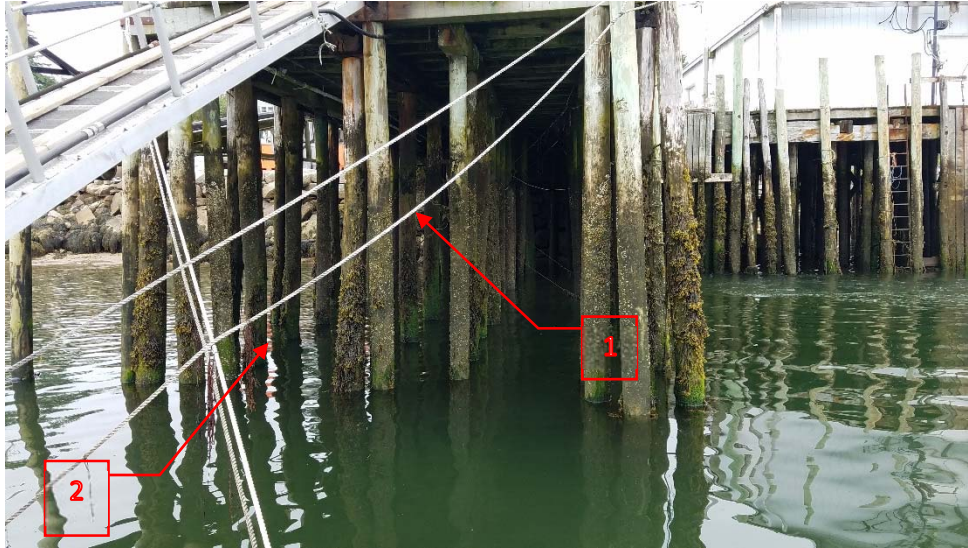
Photograph No. 23:

View of pier facing north.

- 1. Rope attachment to pier for floating dock.**
- 2. No signs of lateral bracing noted.**

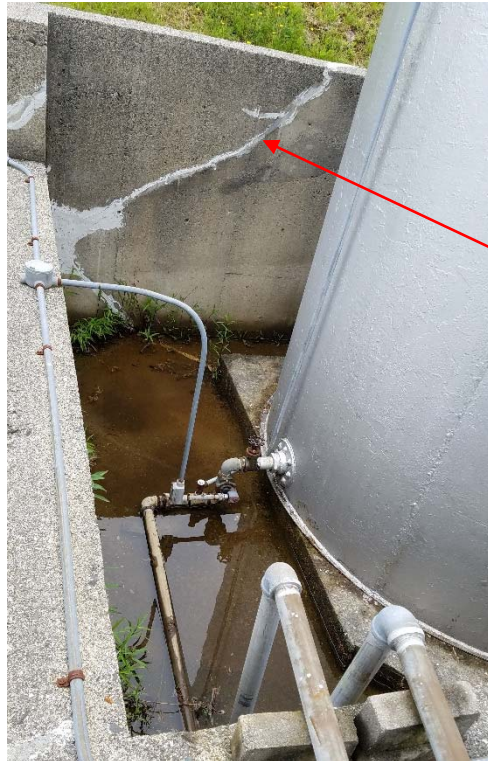
Photograph No. 43:

- Concrete cracking and/or delamination (**Photograph 43**) – Crack noted in concrete enclosure wall for fuel tanks. An attempt at a previous repair was noted which appears to be inadequate from visual inspection.
- Deteriorated wood members (**Photograph 5 – 12, 17, 18 & 23**) – Minor to moderate deterioration of wood members at various locations throughout the pier structure.

Close up of concrete vault, tank and fuel supply lines.

View of existing crack and previous repair in concrete enclosure wall.

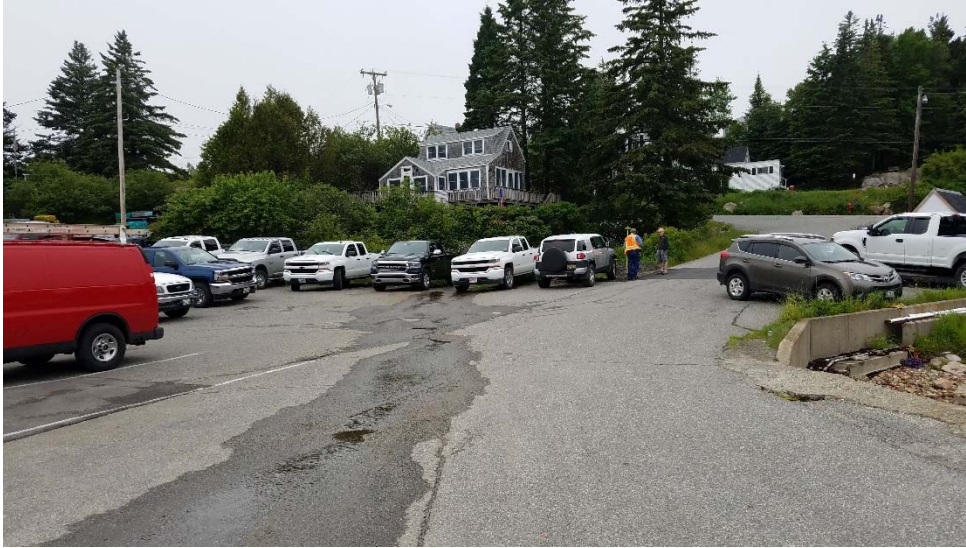
Photograph No. 51:

**View of site at south end
(Pier) facing north.**

**Some surface deterioration
noted in top coat.**

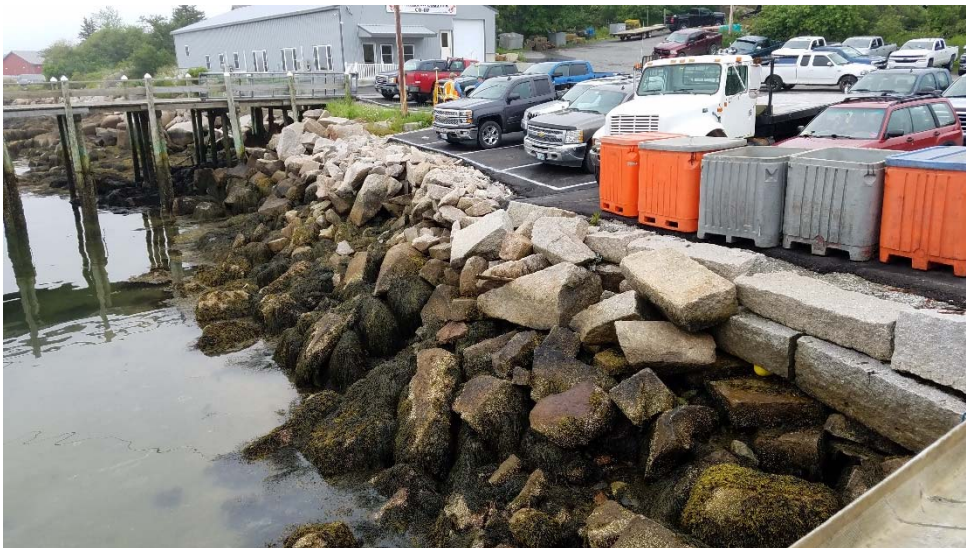
Photograph No. 52:

Shoreline protection is provided in the form of a riprap revetment. No signs of material degradation or slope instability or piping were noted. For the Present Day, Short and Mid Term scenarios, there is minimal risk foreseen based on the data in **Table 4**. Some overtopping is noted for these scenarios, ranging from 2 to 4 feet, but we do not expect it will undermine the revetment. For the Long Term scenario, a future risk is identified due to higher water levels and waves. Under wave attack, randomly placed riprap will experience some settlement and readjustment; however, the risk of wide-scale riprap slope failure appears low.

**View of revetment
composed of stone blocks.**
