TMDL Assessment Summary

Logan Brook

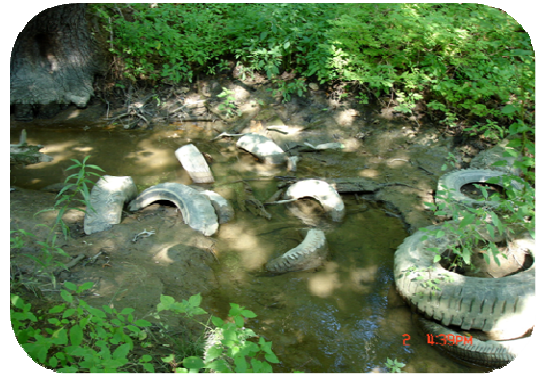
*Tires and trash in Logan Brook.
(Photo: DEP Biomonitoring Program)*
