Status of Western Maine Stream Restoration Projects

FISHERY INTERIM SUMMARY REPORT SERIES NO. 08-07
STATUS OF WESTERN MAINE STREAM RESTORATION PROJECTS

JOB NO. F-027
WESTERN MAINE STREAM RESTORATION
INTERIM SUMMARY REPORT NO. 1 (1998-2008)

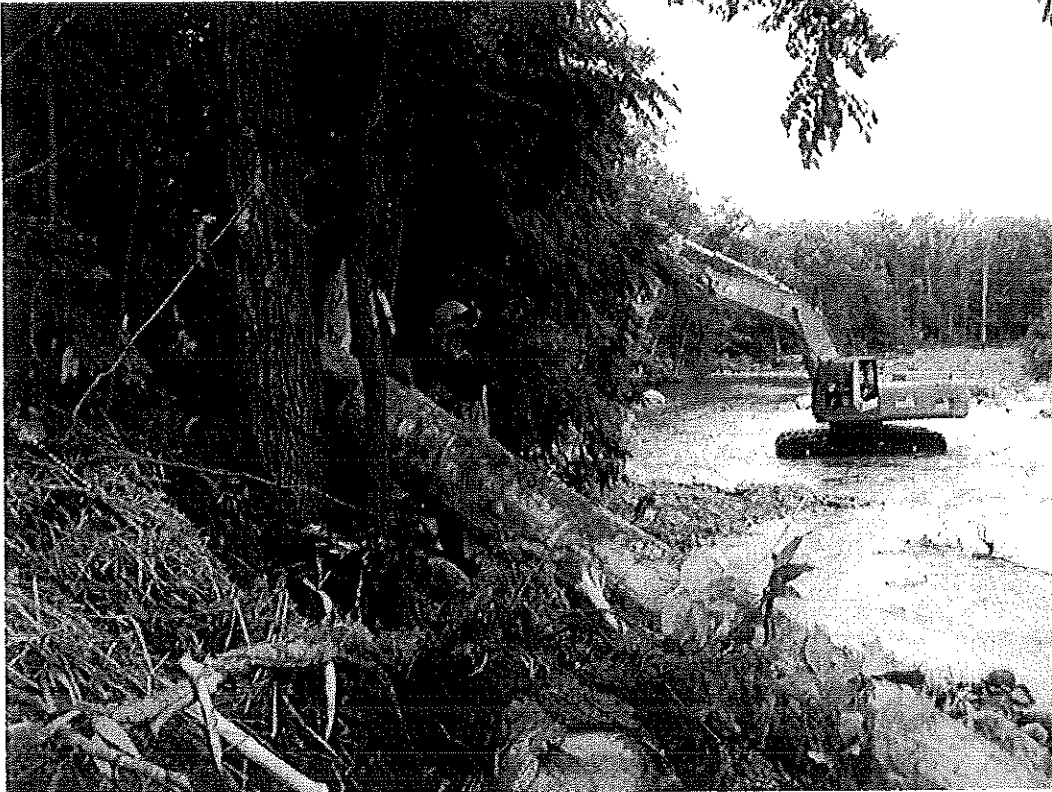
Bar buddies being placed between rock vanes in Sunday River, 2008, to stabilize shoreline.

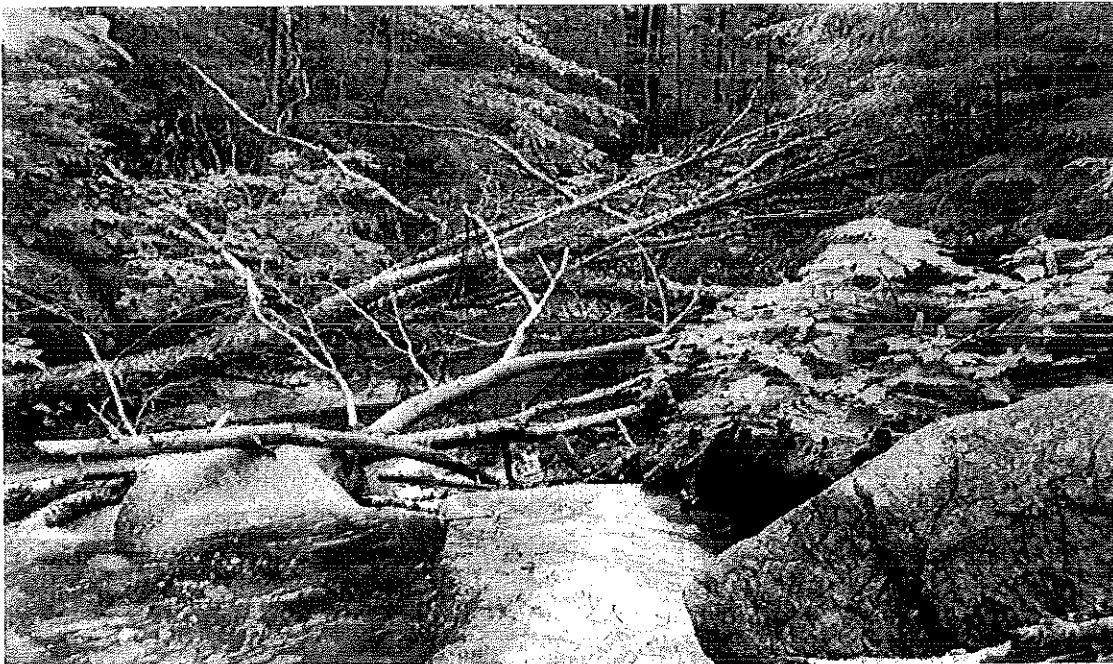
Newly-cut coarse woody debris, upper Sunday River, 2007.

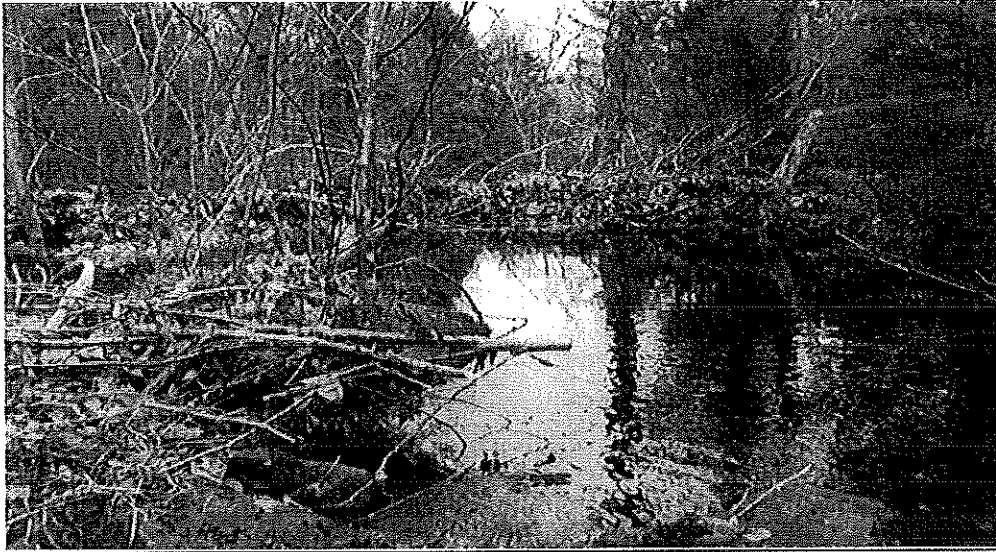
Coarse woody debris, upper Sunday River, 2008, one year after placement, showing consolidation of stems, resultant pool formation, and trapping of organic material.

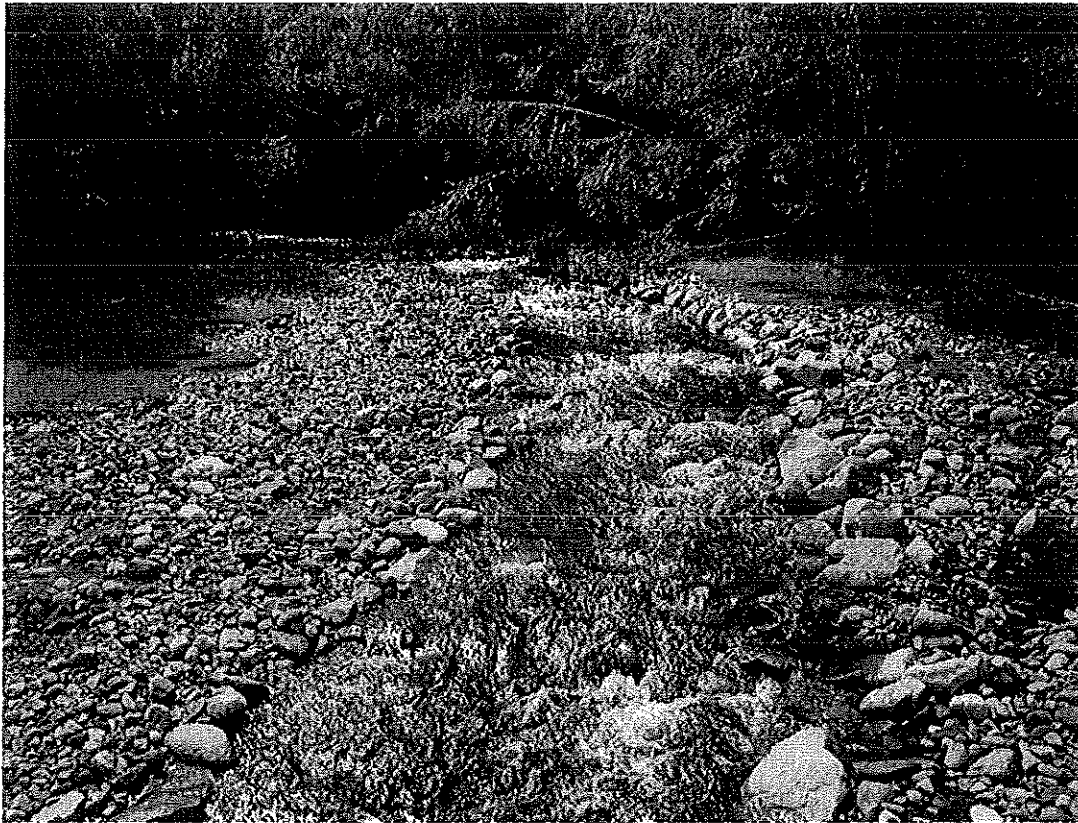
Keystone rock structures, South Bog Stream, four years after construction, showing concentrated flow and riffle-pool sequence.

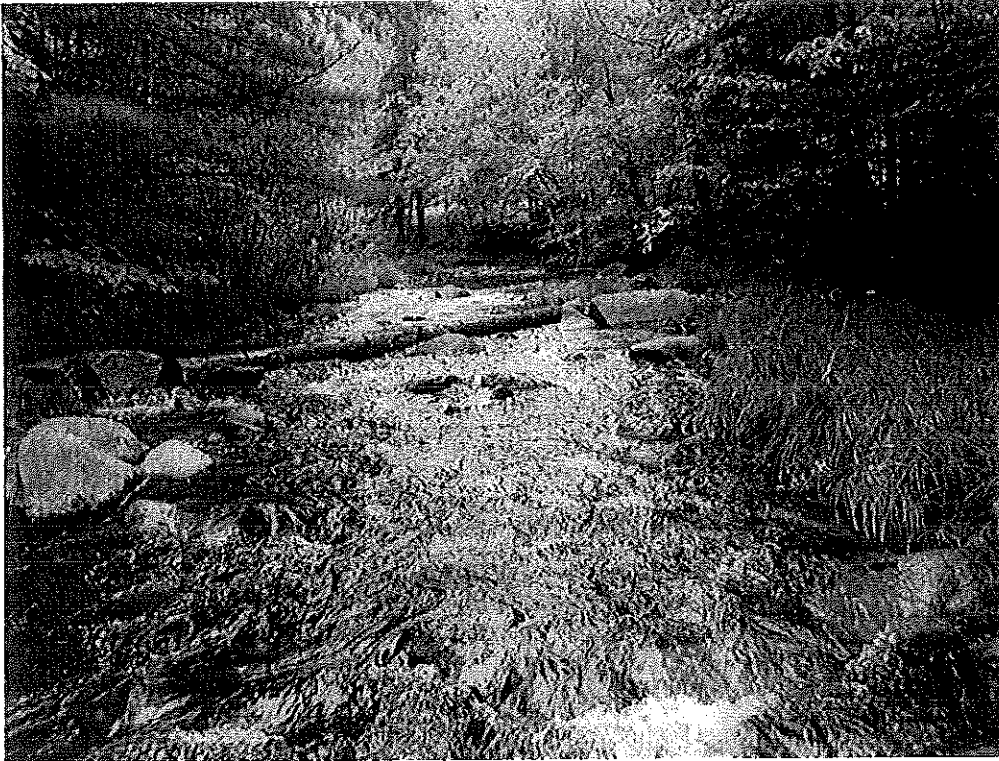
Cabled log, Sandy River, placed in 2007 to divert flow and narrow channel.

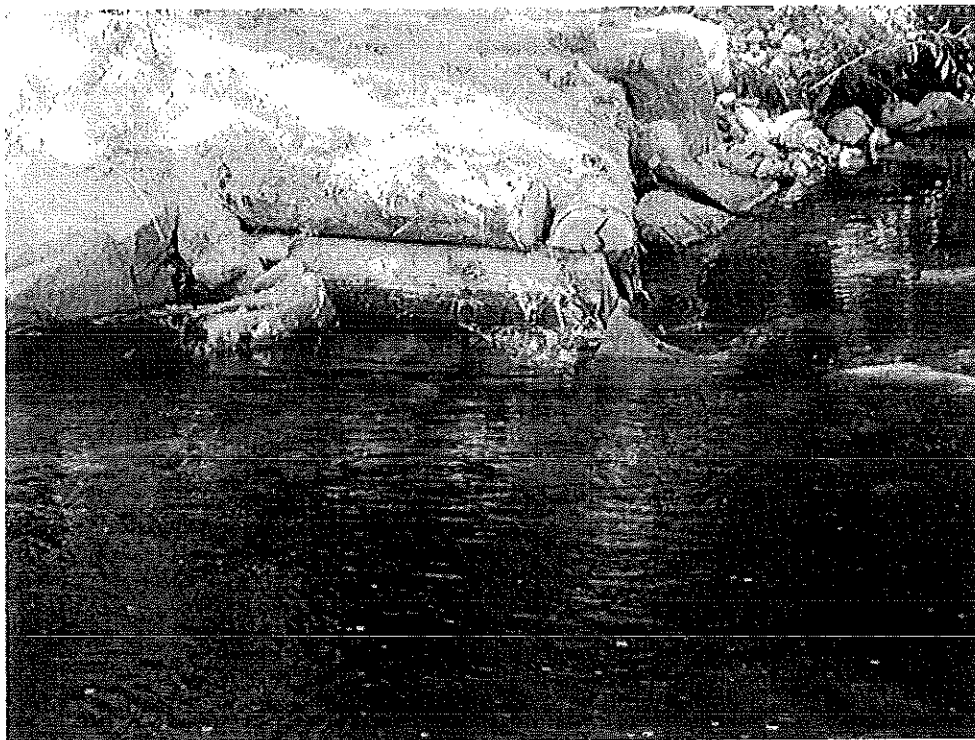
Log wing deflector, South Bog Stream, installed 2004 to narrow channel and trap sediment.

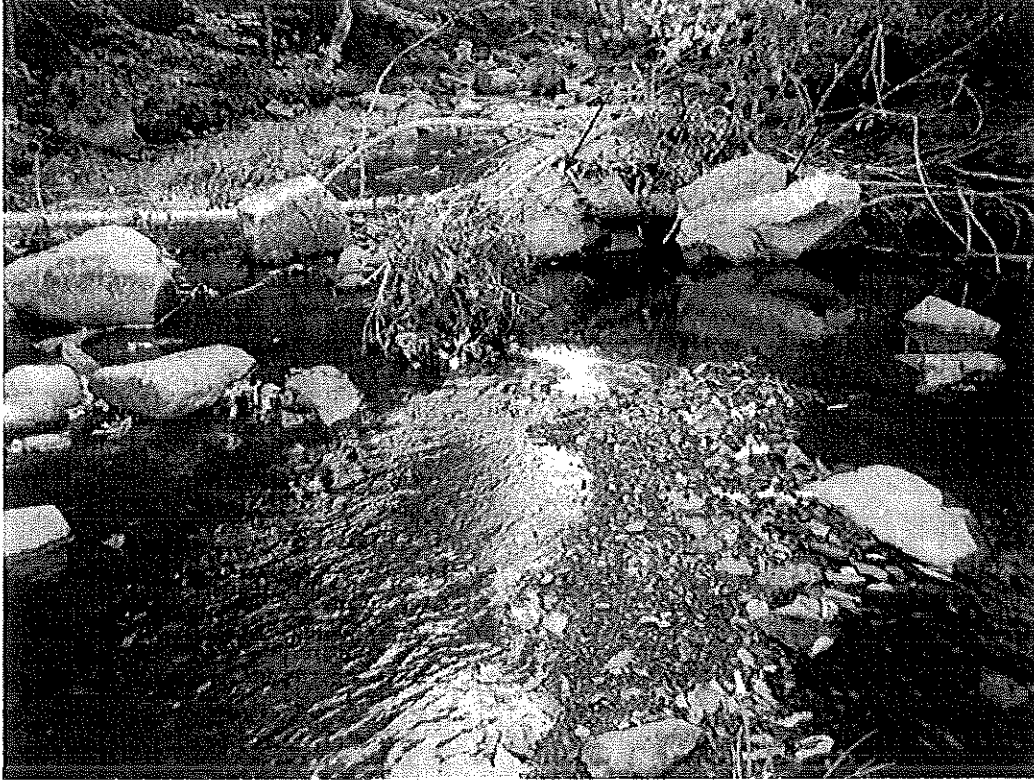
Paired boulders, Sandy River, showing scoured pool, "tailings", and recruited woody debris.

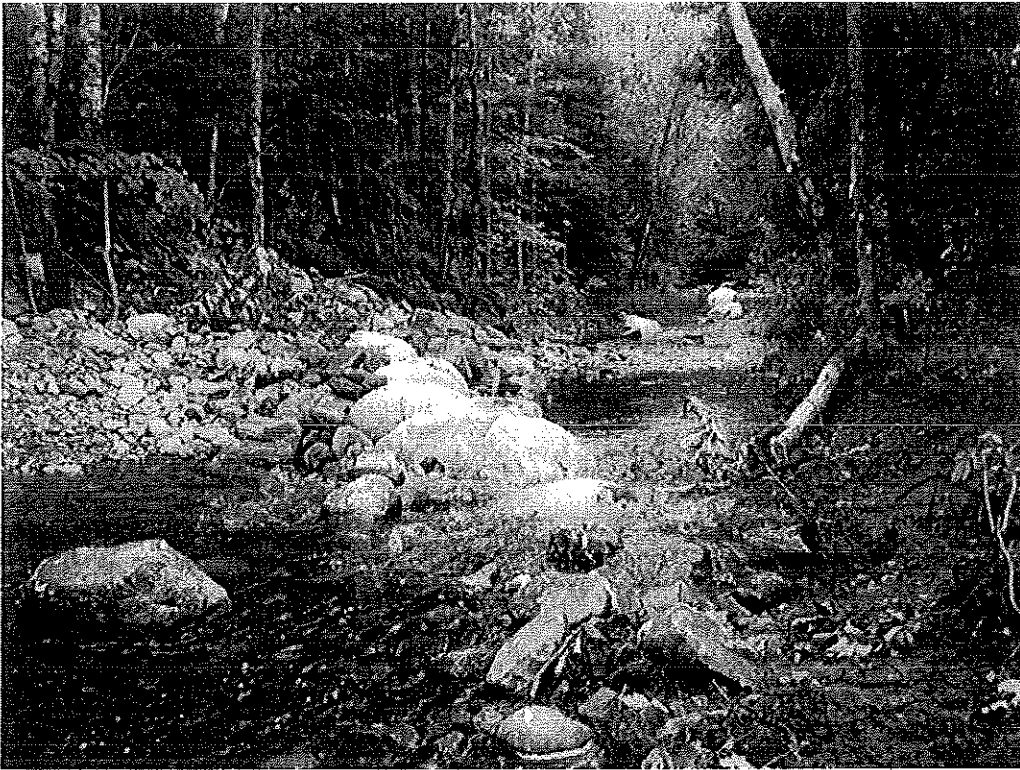
Rock sill, East Branch Enchanted Stream, constructed 2008 to encourage meander development and to scour pools.

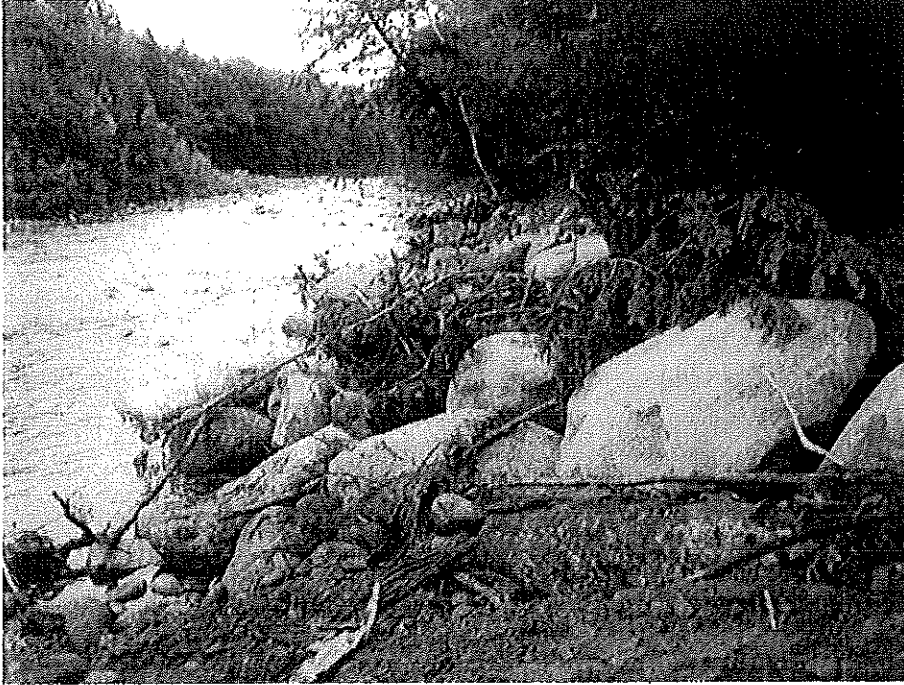
Rock vanes, Sunday River, installed 2008 to divert flow away from bank, trap sediment, narrow stream, and create pools.

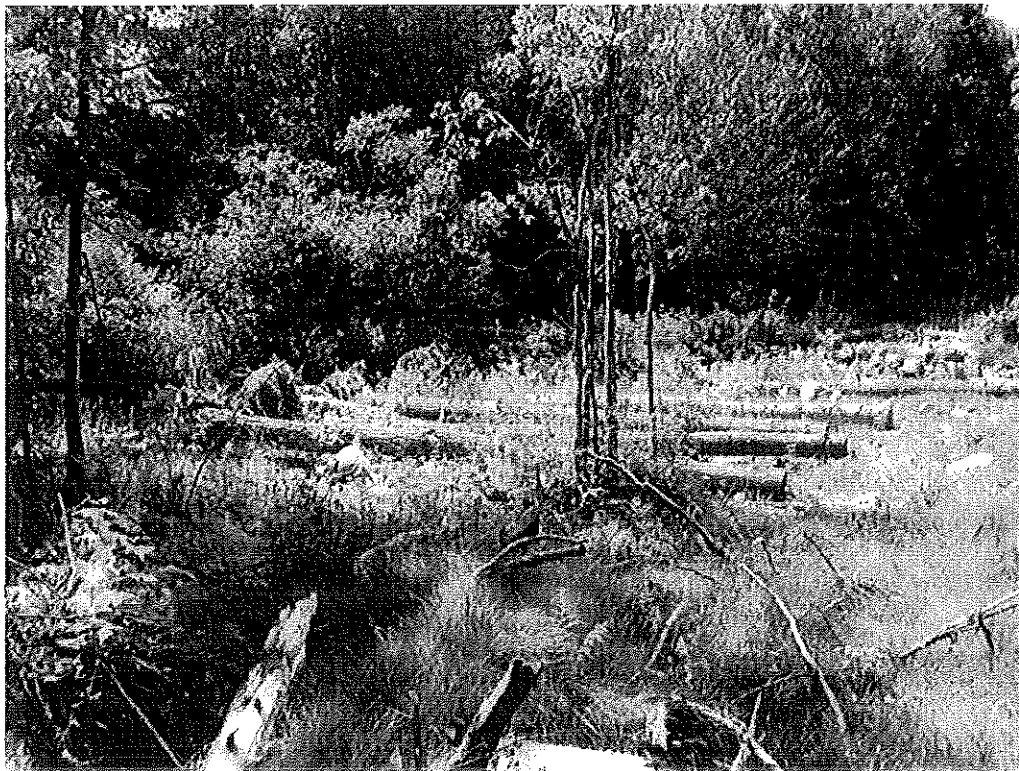
Root wads, South Bog Stream, placed to trap sediment and narrow an overwidened reach.
