Project Number: 3611191238

**Subject: Penobscot Bay Vulnerability Assessment and Resilience Planning – Draft Summary Report  
Maine Coastal Program, Maine Department of Marine Resources**

Penobscot Bay Working Waterfront Resiliency Analysis  
Maine Coastal Program  
Maine Department of Marine Resources

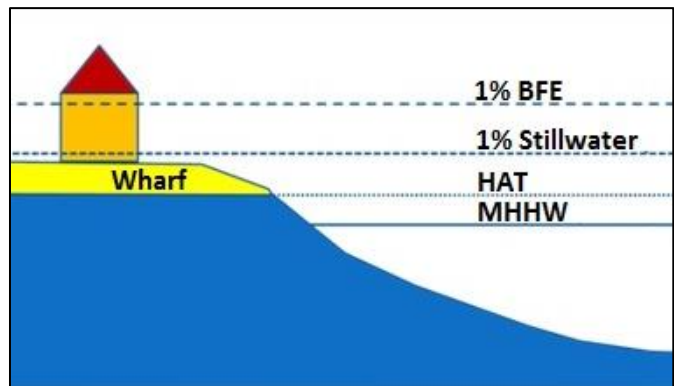
The present day MHHW and HAT tidal datums were sourced from the nearest long-term NOAA tide station and from spatial files developed by Maine Geological Survey (MGS)<sup>1</sup>. The present day 1%-annual-chance still water level was obtained from the 2016 Federal Emergency Management Agency (FEMA) Flood Insurance Study for Knox County. Site-specific wave modelling was conducted for existing and future sea levels to better quantify wave hazards and potential increases in wave heights at the site. Wave modelling was conducted using FEMA’s overland wave modelling approach for consistency in providing an estimate of the 1% BFE for the future scenarios. The relative positions of the reference elevations are shown on the adjacent figure insert.

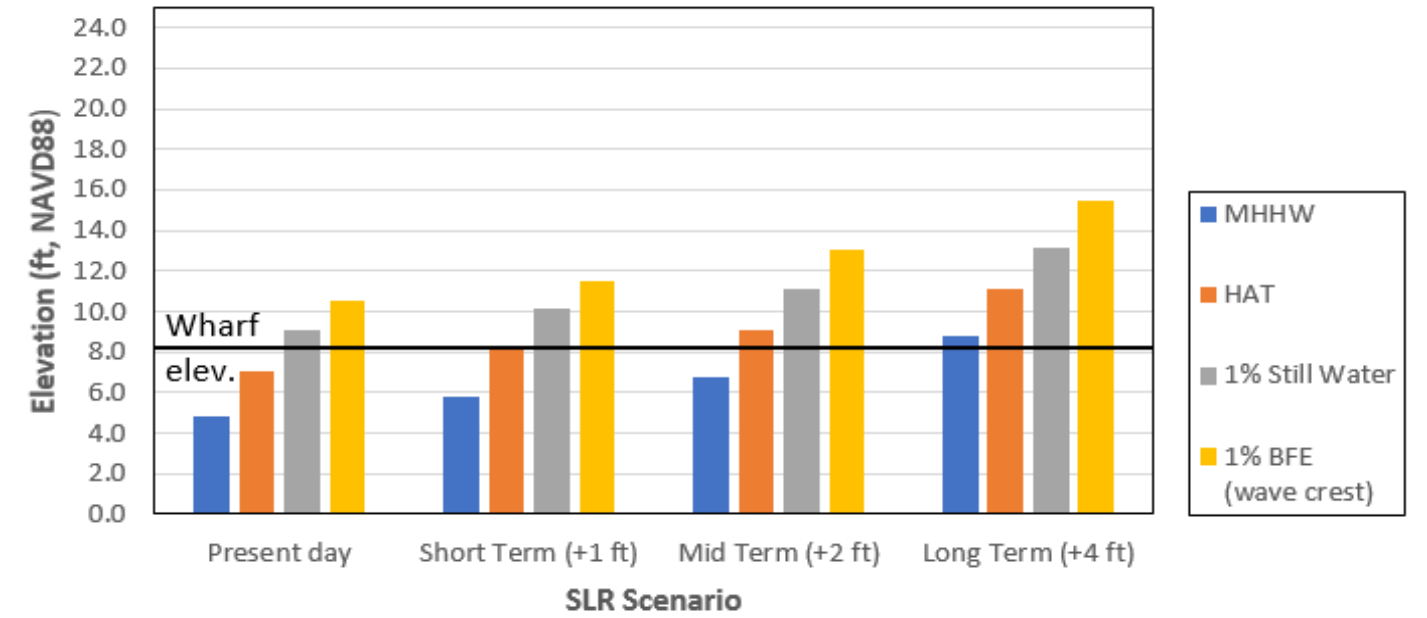
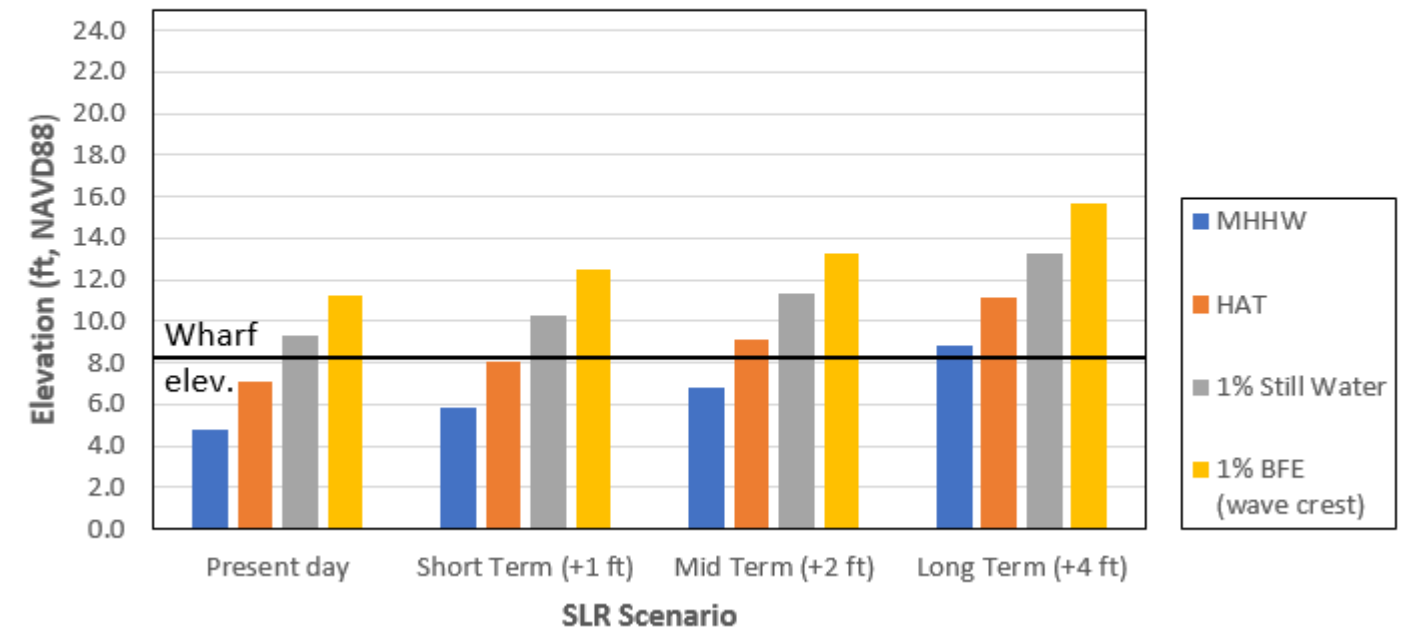
Figure 2A  
Water Level Elevation Summaries

### Water Level Elevation Summary Middle Pier, Rockland

### Water Level Elevation Summary Public Landing, Camden

### Water Level Elevation Summary Municipal Fishing Pier, Lincolnville

### Water Level Elevation Summary Public Landing, Belfast

The plots on **Figures 2A through 2C** depict the relationships between critical infrastructure elevations and existing and potential future modelled flood elevations for the eight sites where working waterfront vulnerability assessments were completed, and the two locations on Island Road in South Thomaston. The plot on **Figure 3** includes a summary of estimated budgets for recommended resilience measures for the eight working water front sites where vulnerability assessments were conducted.

The inundation modeling plots on **Figures 2A and 2B** include water level elevations (NAVD 88) for MHHW, HAT, 1% Still Water and 1% BFE. The 1% BFE incorporates wave heights which range from 1 (present day) to 7 feet (long term). Average wave heights were used for each SLR scenario on the plots. The site-specific elevation of a pier or wharf was included on each plot as a benchmark for interpreting the extent of potential inundation. Key findings based on the modeling data include:

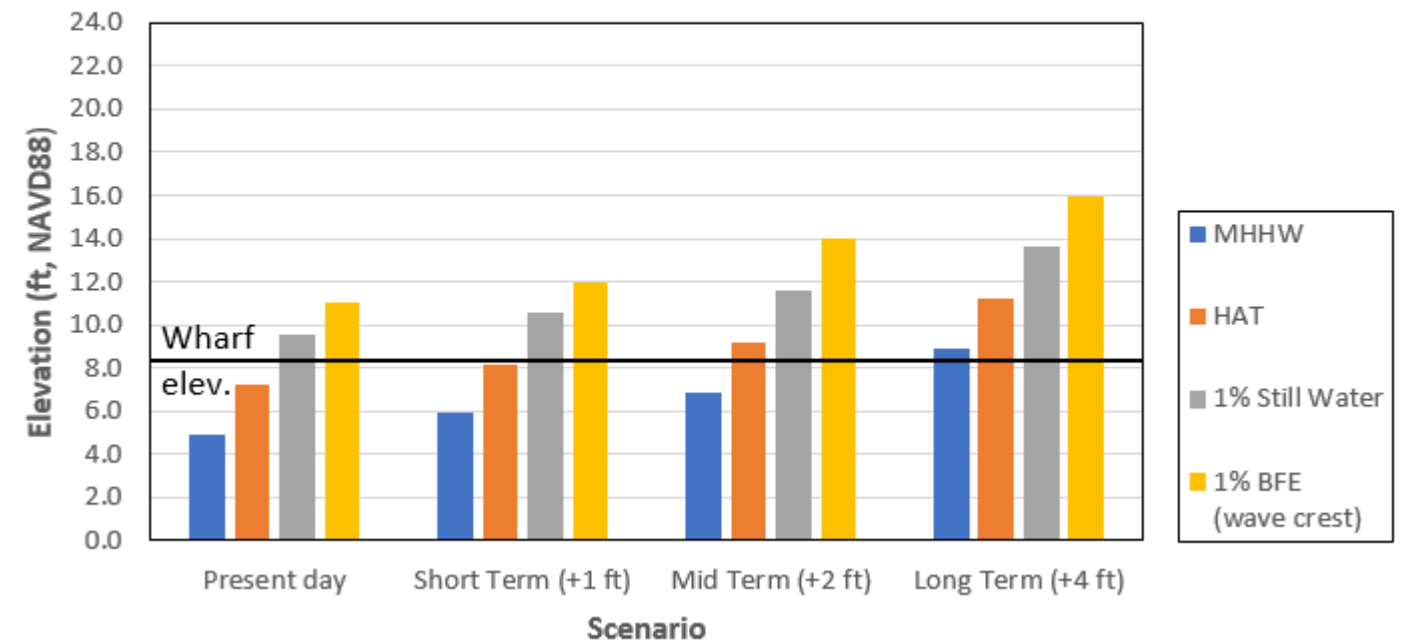
Figure 2B  
Water Level Elevation Summaries

### Water Level Elevation Summary Hamilton Wharf, Searsport

### Water Level Elevation Summary Ferry Terminal, Vinalhaven

### Water Level Elevation Summary Lobster Coop, Stonington

### Water Level Elevation Summary Town Dock, Castine

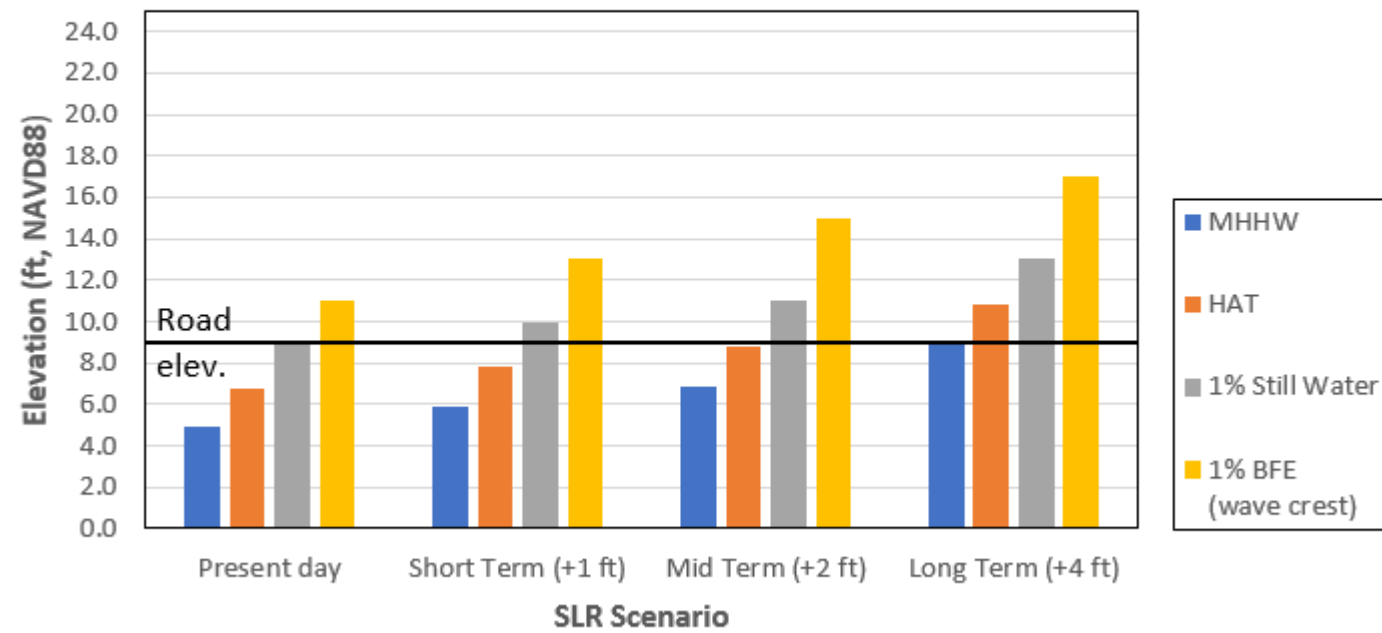
Figure 2C  
Water Level Elevation Summaries

Water Level Elevation Summary  
Island Road at Transect 1, South Thomaston

Water Level Elevation Summary  
Island Road at Transect 2, South Thomaston

WHG conducted modelling of inundation at Areas A and B on Island Road using similar methodology as the eight working waterfront sites discussed above. The results of flood modelling are summarized on **Figure 2C** and provided in **Appendix B** which includes maps depicting the 1%-annual-chance flood zones and BFEs for each SLR scenario. The South Thomaston site

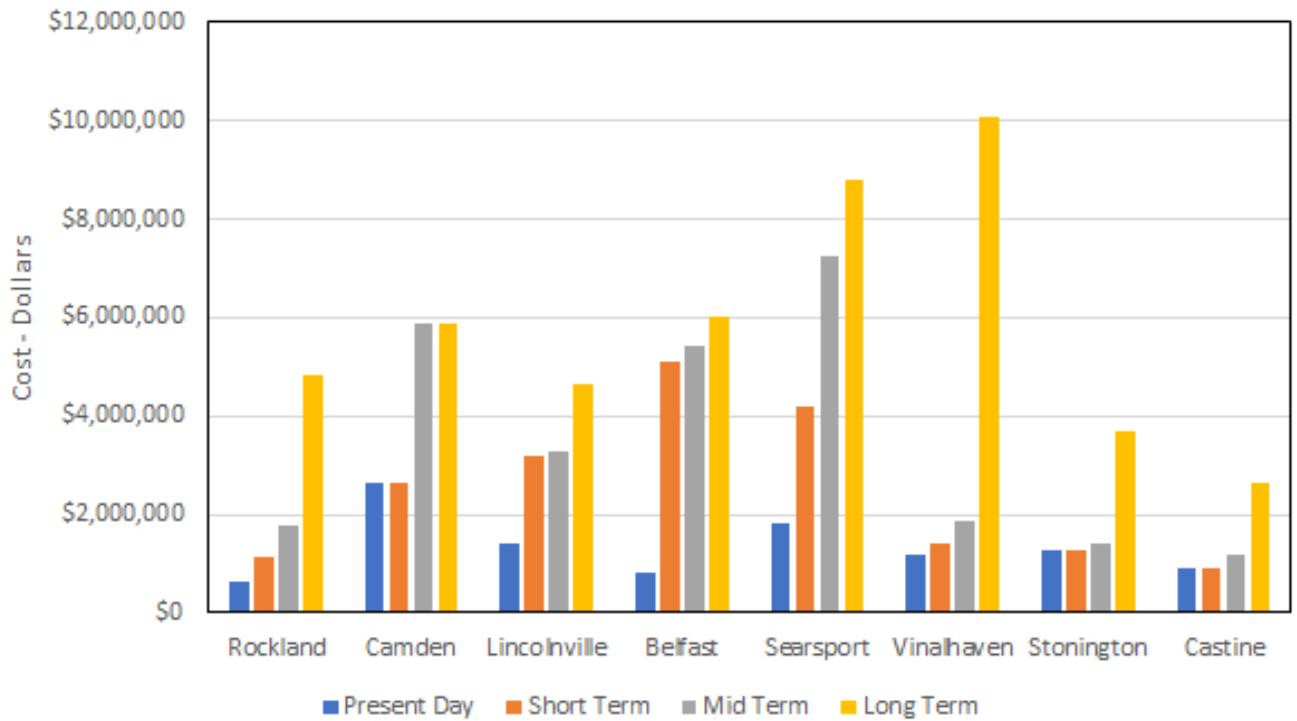
Figure 3  
Budget Summary

## Budget Summary Penobscot Bay Resilience Project Sites

Evaluation of the eight working waterfront sites included budget estimates for implementation of resilience measures for various flood and sea level rise scenarios. A summary of the budgets is provided on **Figure 3**. As shown, the budget estimates range from around \$300K for improvements under the Present Day scenario at Rockland, to about \$10M for improvements relating to the Long Term scenario at Vinalhaven, driven largely by the cost of ferry terminal resilience measures. The estimated budgets are intended as a planning tool for helping inform preliminary resilience measure prioritization. Actual budgets will vary based on options selected, timing, results of engineering studies and contractor-derived quotes, among other factors.

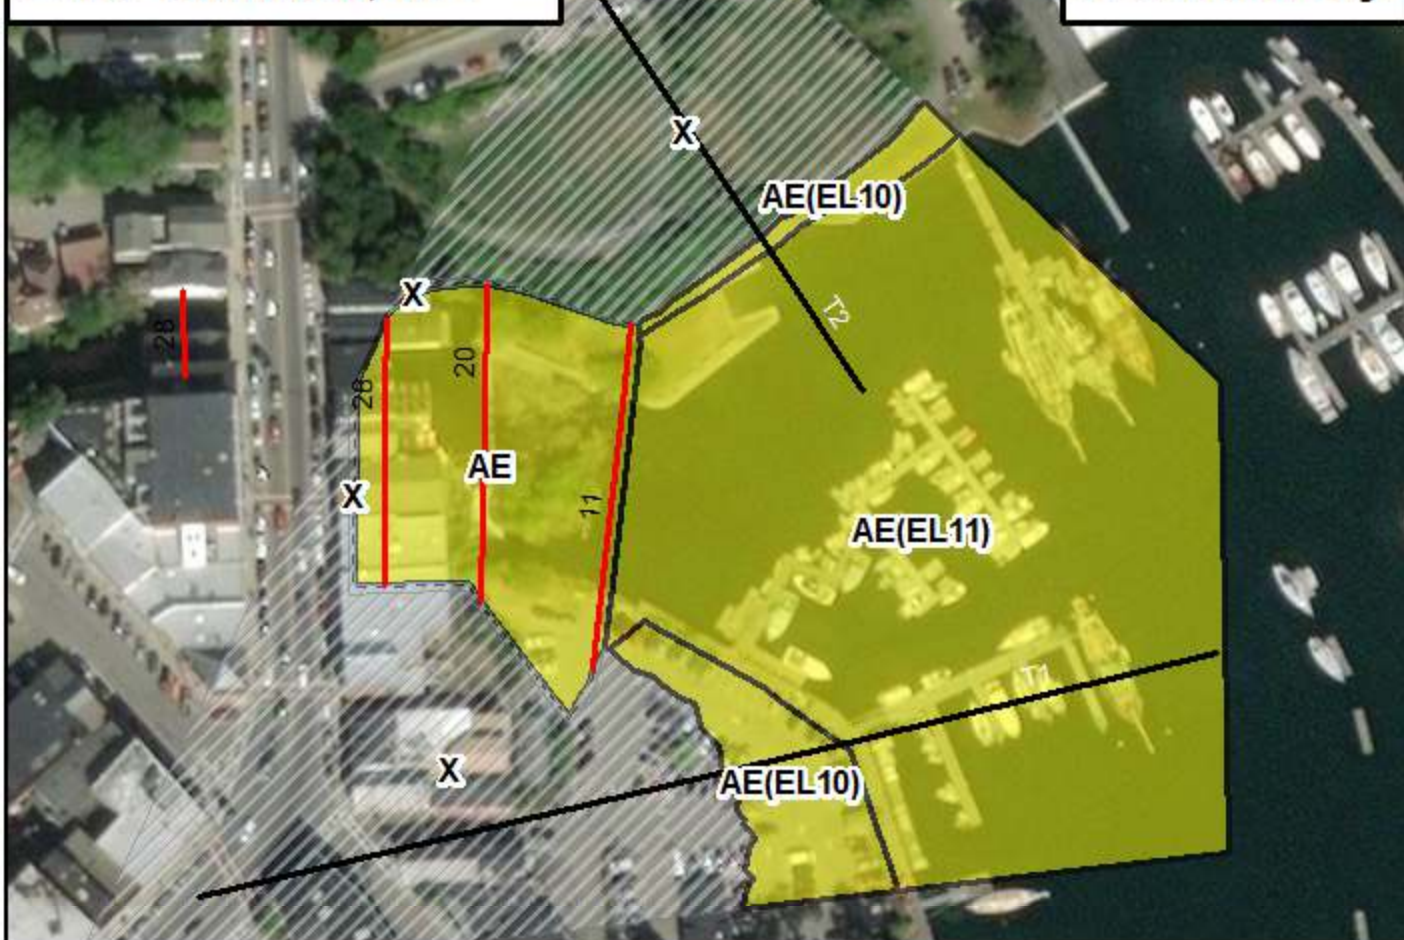
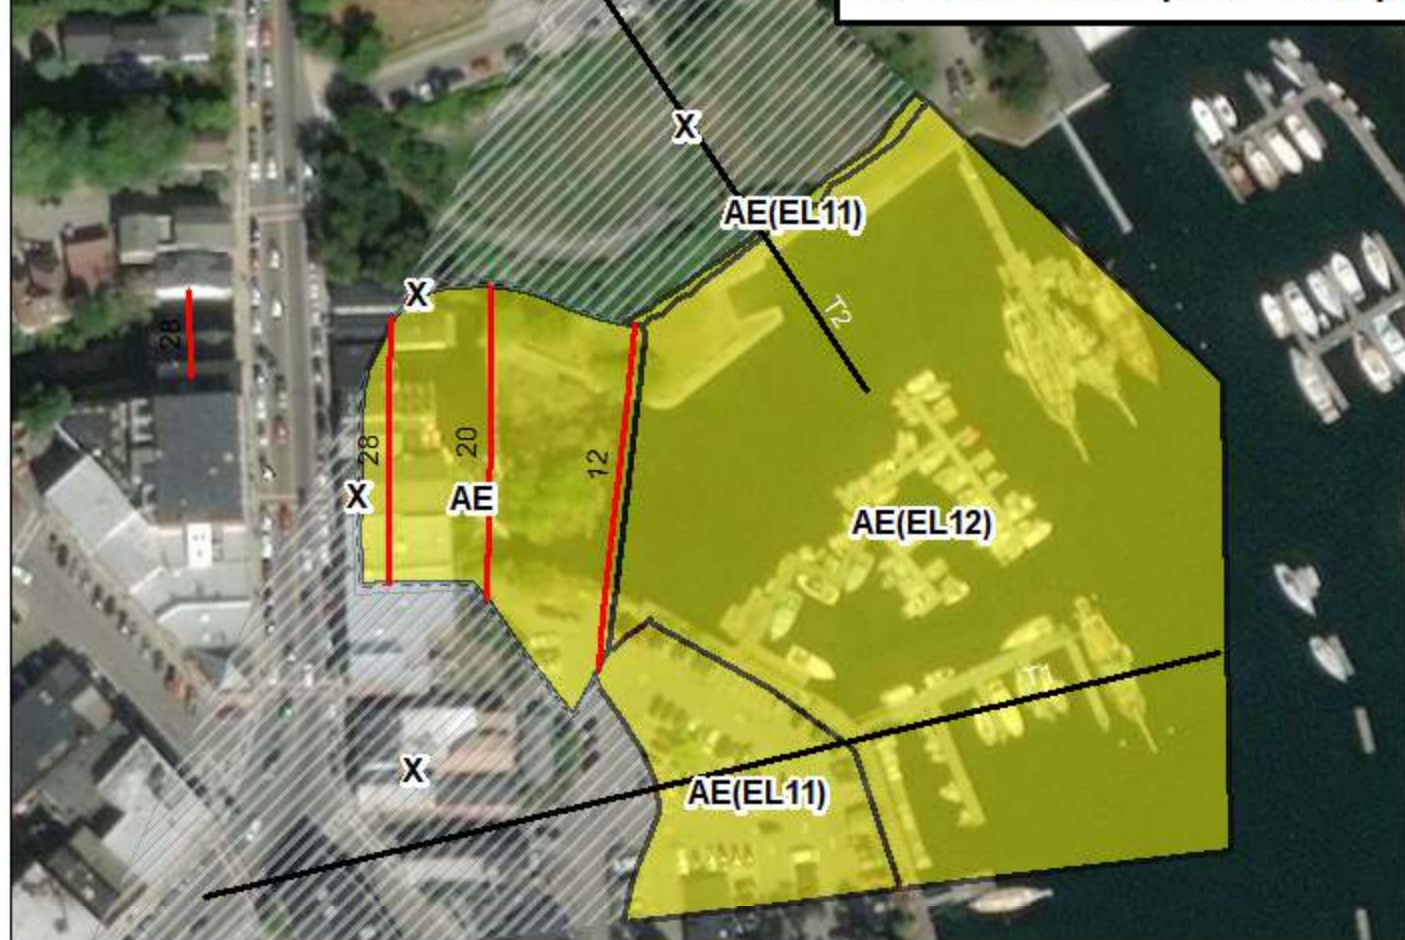
Site: Camden, ME

Present Day

Short Term (1 ft SLR)

Mid Term (2 ft SLR)

Long Term (4 ft SLR)

1. Maps indicate the 1%-annual-chance flood zones and base flood elevations.
2. This does not constitute a revision to the FEMA FIRM map which is done through FEMA's Letter of Map Revision process for which additional analysis and/or modeling may be required.
3. Flood mapping was developed for planning purposes only. No other use of this map should be made.
4. Elevations in reference to vertical datum NAVD88

As broadly indicated by the maps for each site, flood zones predicted for the 1% flood event (including wave action) extend progressively landward with increasing SLR. The result is an increase in inundation depth for vulnerable waterfront structures as SLR increases. It should be noted that wave heights attenuate rapidly once flood water meets the shore (i.e., typically within 100 ft for most storm scenarios).

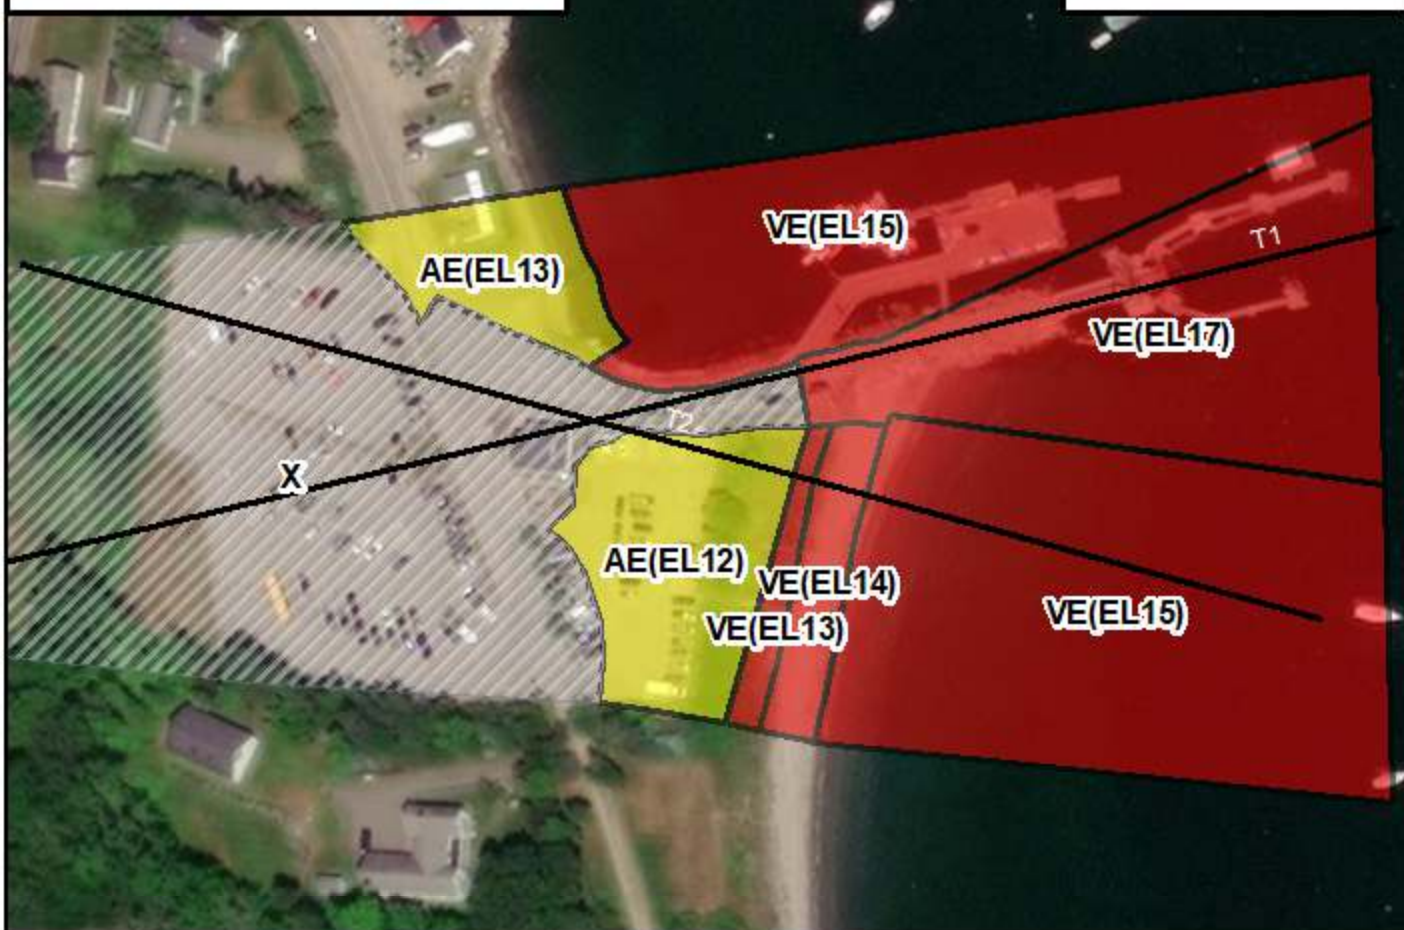
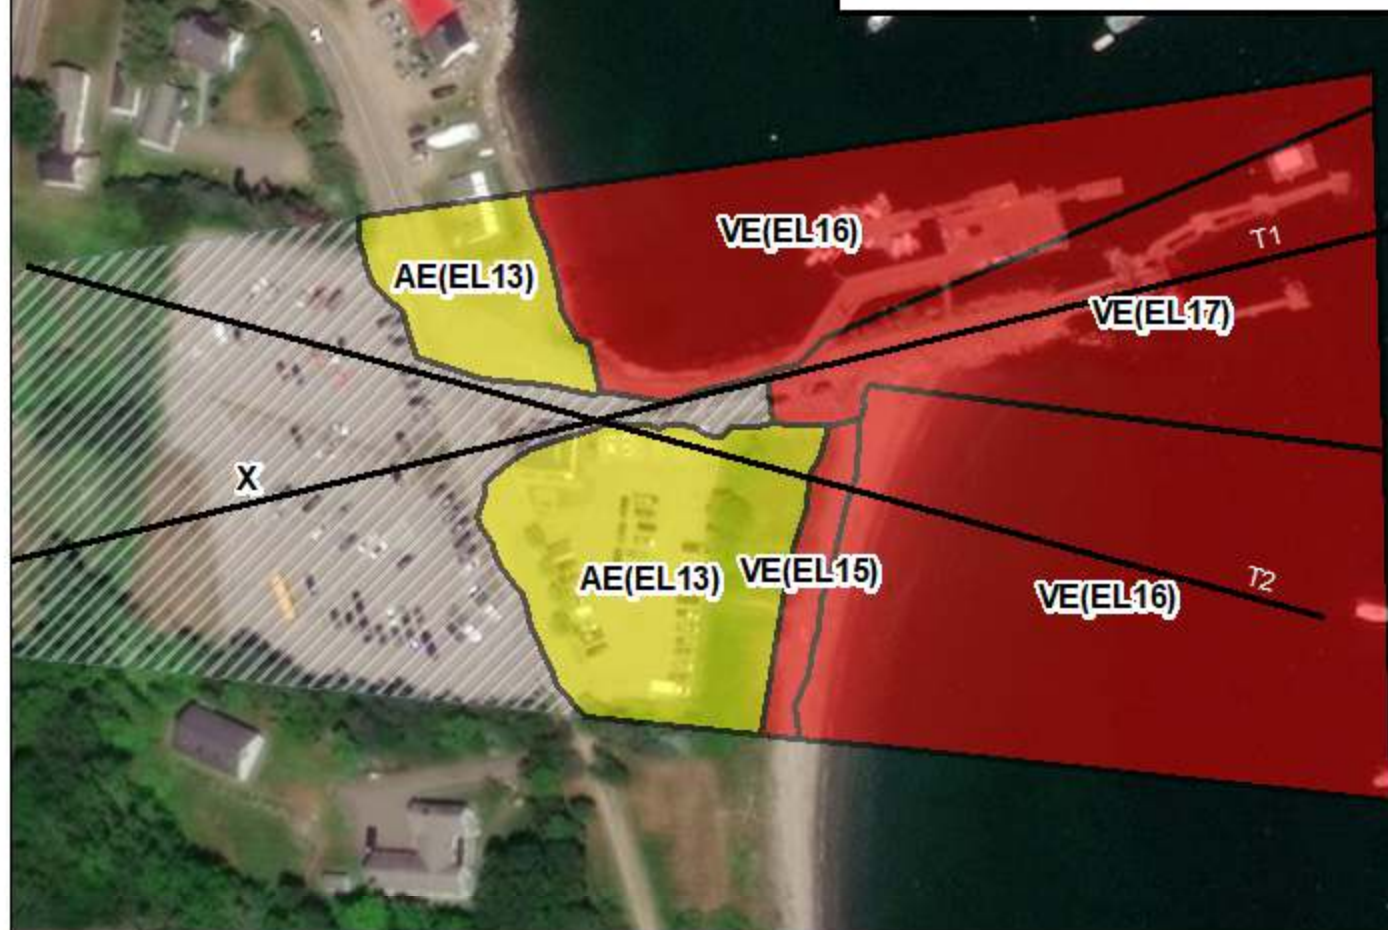
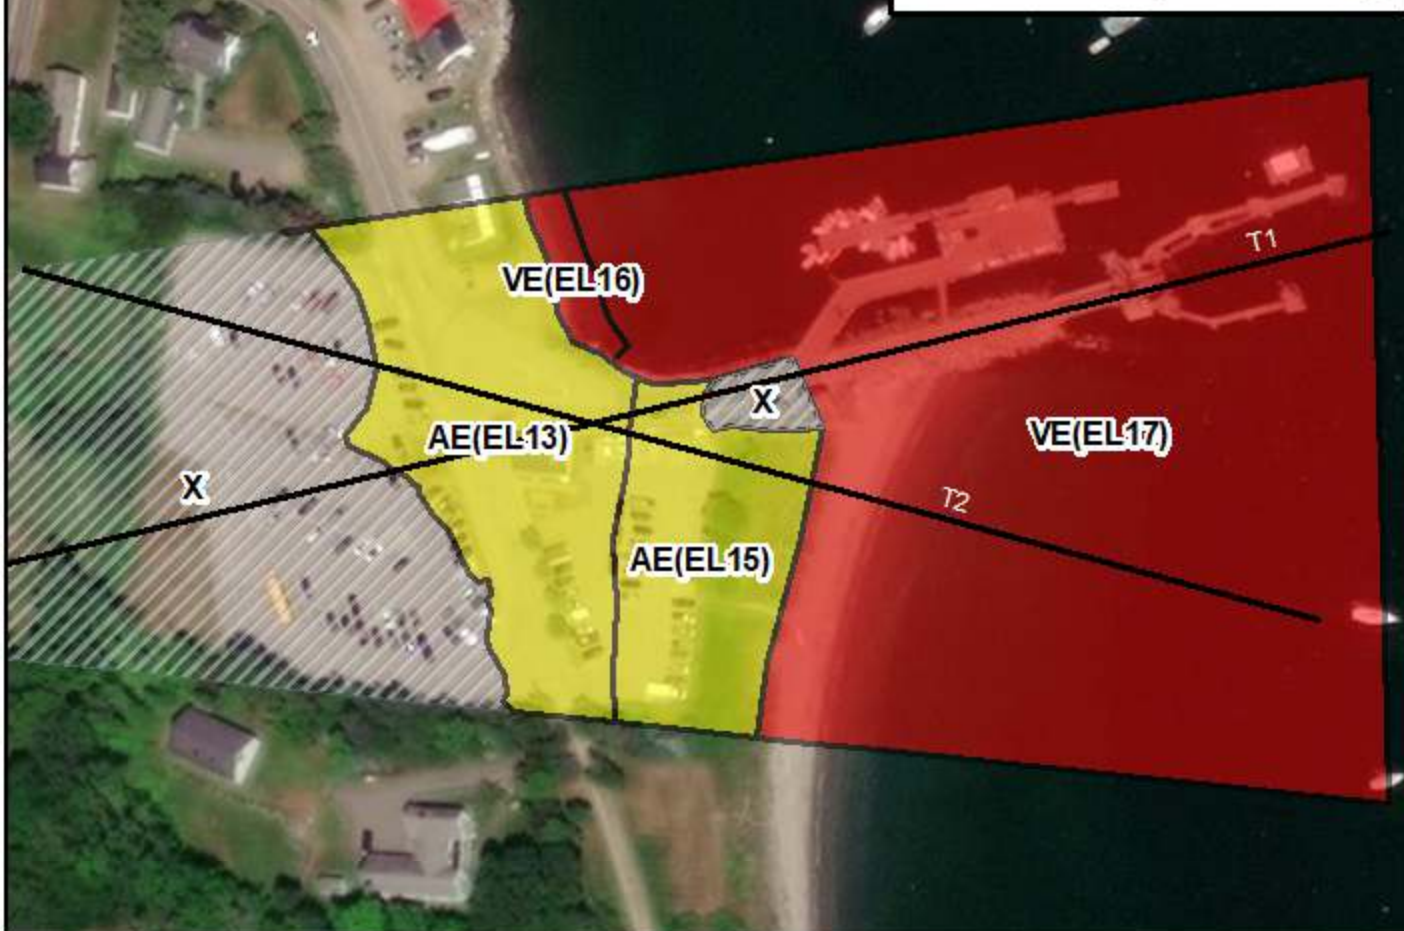
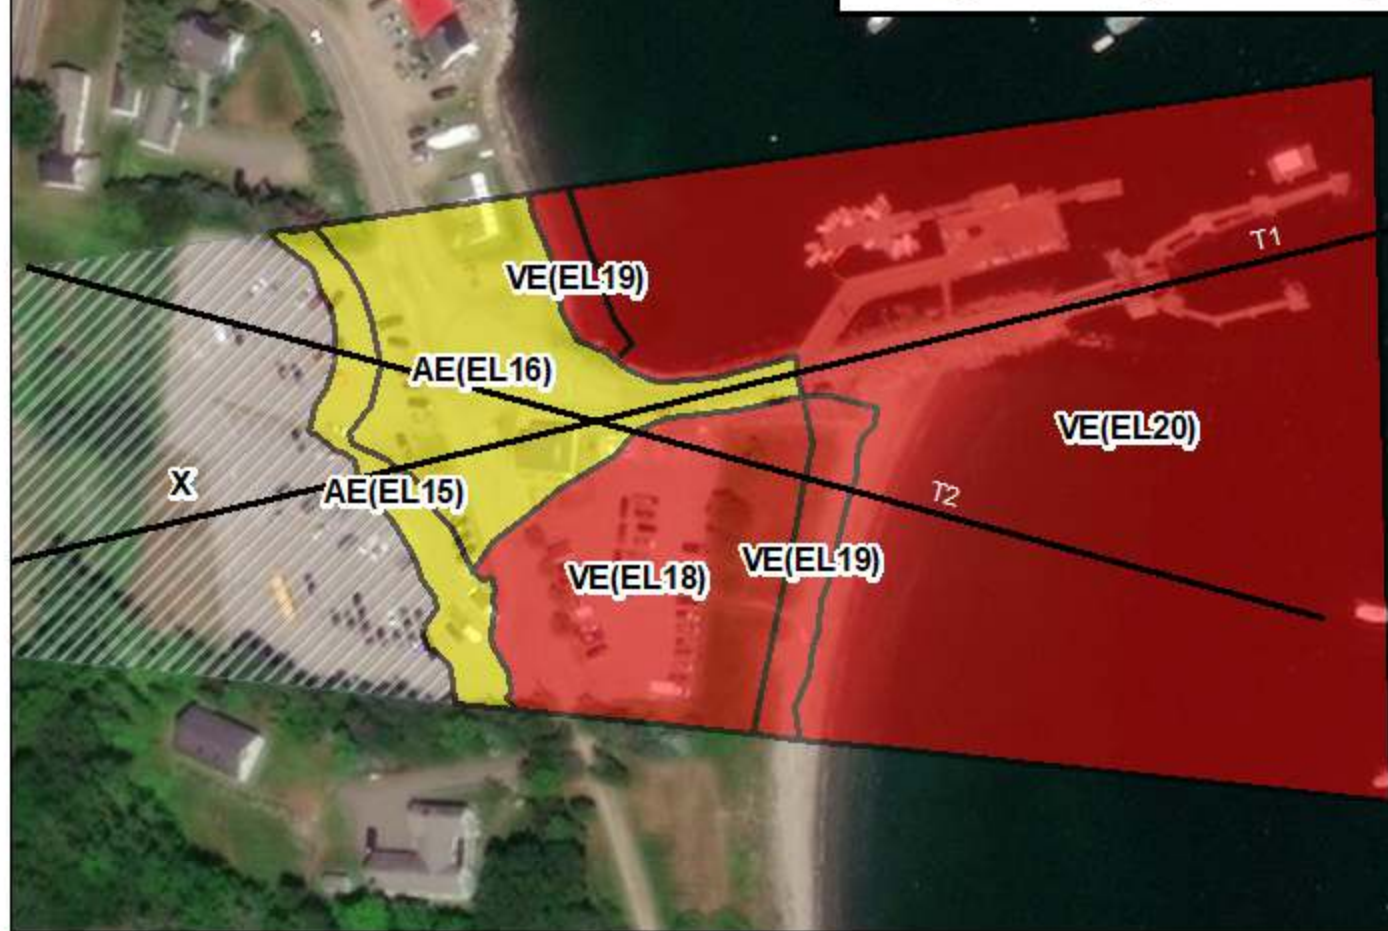
Site: Lincolnville, ME

Present Day

Short Term (1 ft SLR)

Mid Term (2 ft SLR)

Long Term (4 ft SLR)

1. Maps indicate the 1%-annual-chance flood zones and base flood elevations.
2. This does not constitute a revision to the FEMA FIRM map which is done through FEMA's Letter of Map Revision process for which additional analysis and/or modeling may be required.
3. Flood mapping was developed for planning purposes only. No other use of this map should be made.
4. Elevations in reference to vertical datum NAVD88

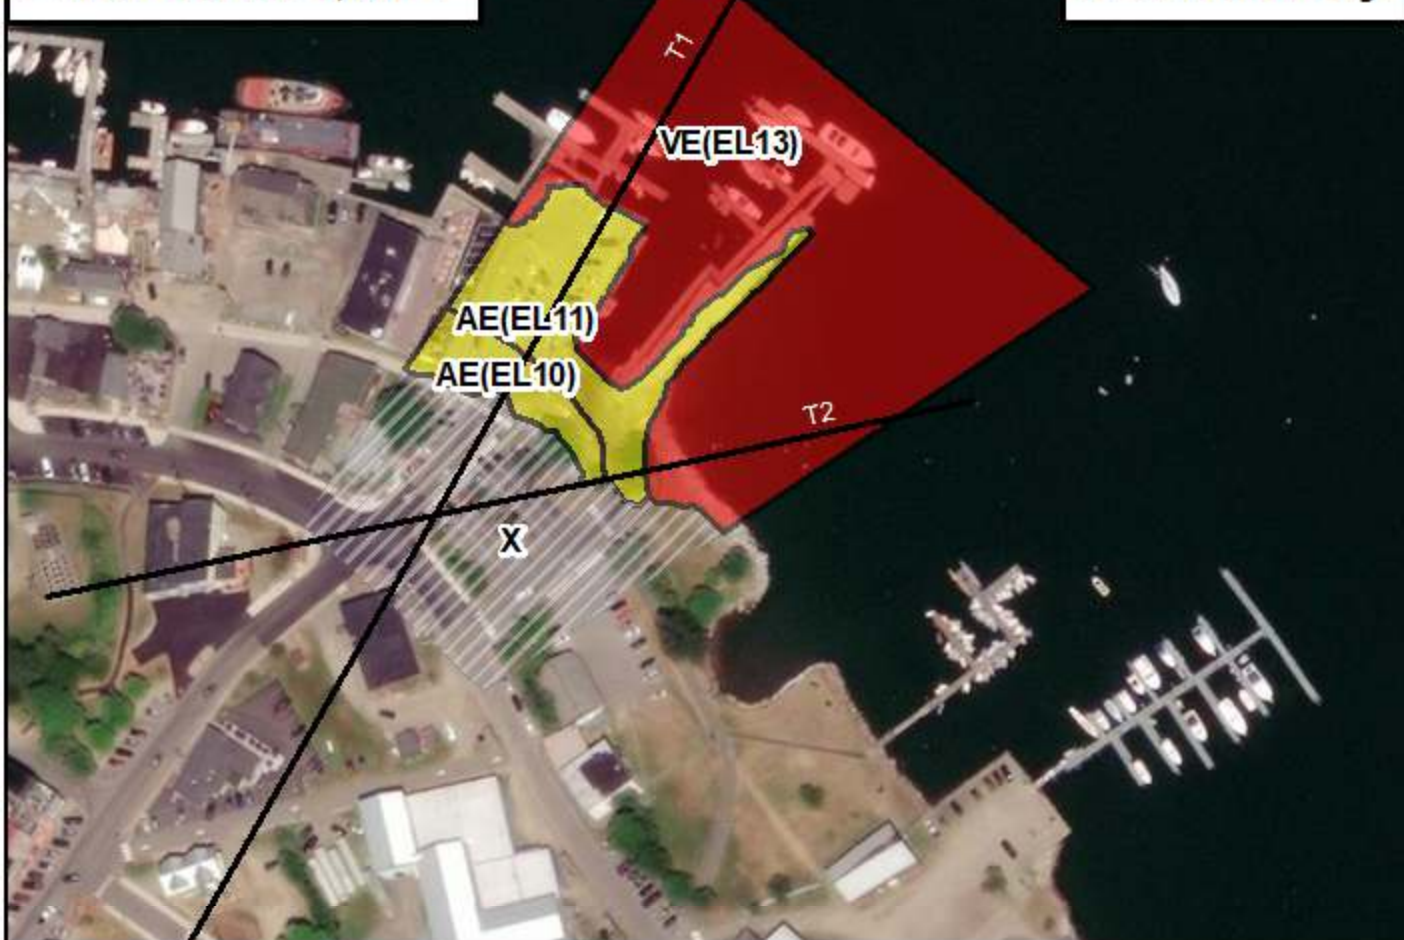
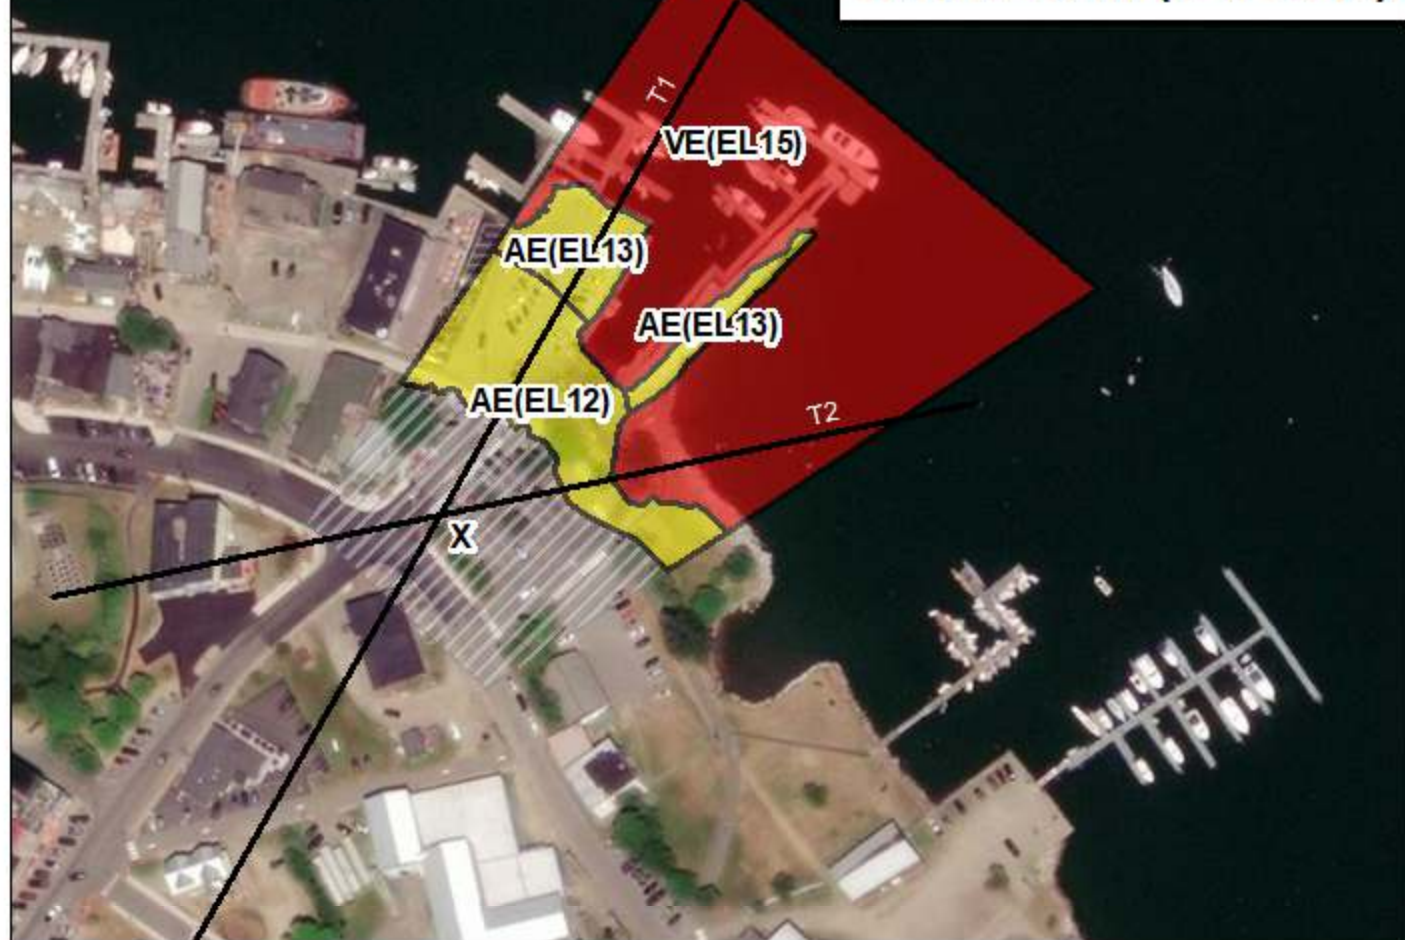
Site: Belfast, ME

Present Day

Short Term (1 ft SLR)

1. Maps indicate the 1%-annual-chance flood zones and base flood elevations.
2. This does not constitute a revision to the FEMA FIRM map which is done through FEMA's Letter of Map Revision process for which additional analysis and/or modeling may be required.
3. Flood mapping was developed for planning purposes only. No other use of this map should be made.
4. Elevations in reference to vertical datum NAVD88

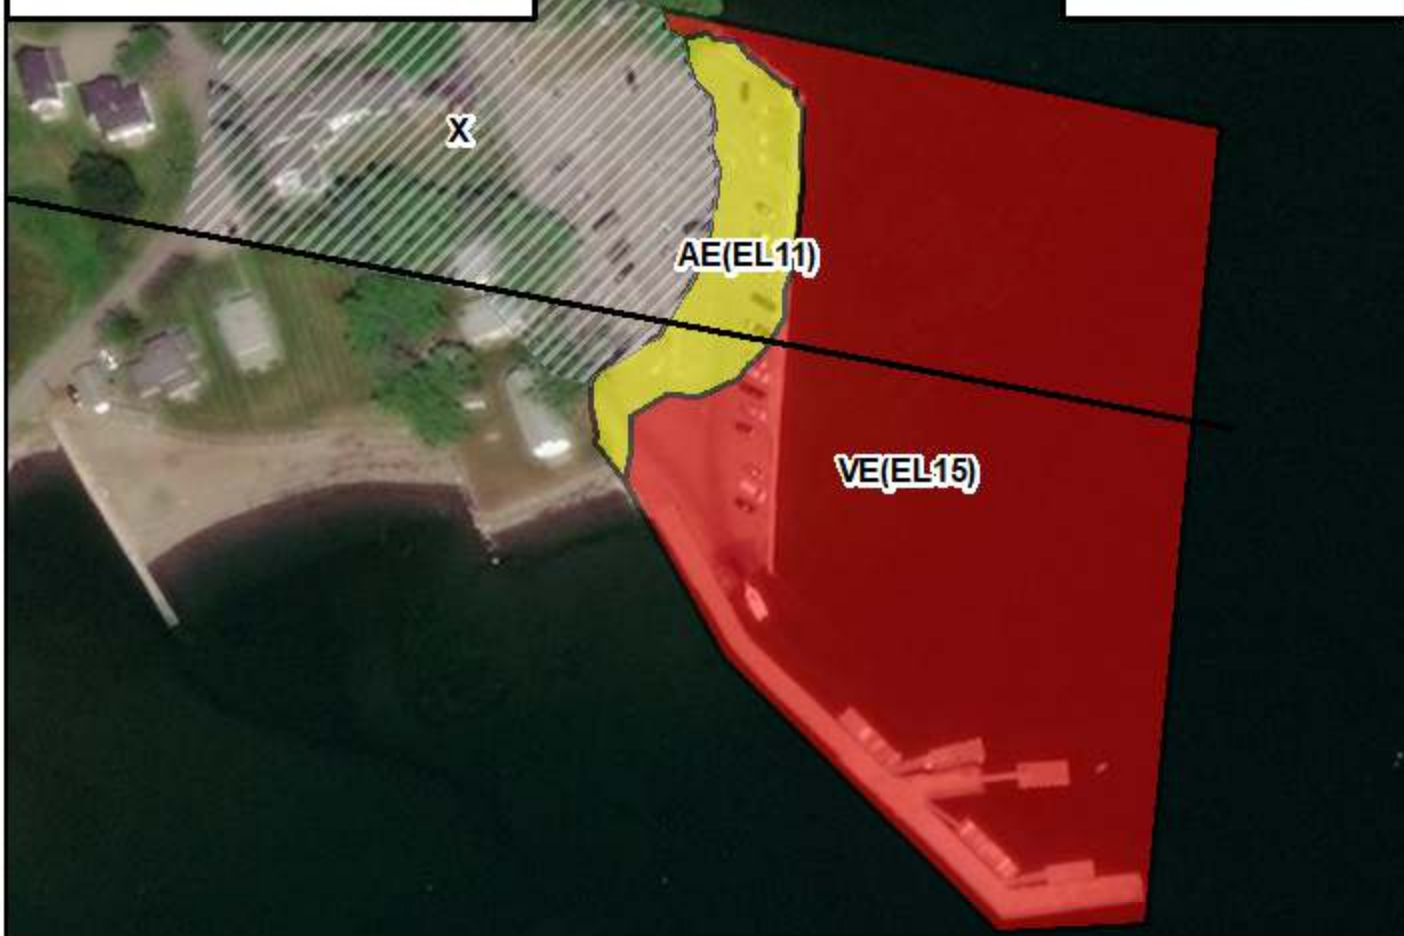
Present Day

Site: Searsport, ME

The flood maps in **Appendix B** depict progressive shrinking of areas outside the 1%-annual-chance flood zone (Zone X) and expansion of areas impacted by flooding in Zone AE (coastal flood zone) and Zone VE (coastal flood zone with velocity/wave hazard).

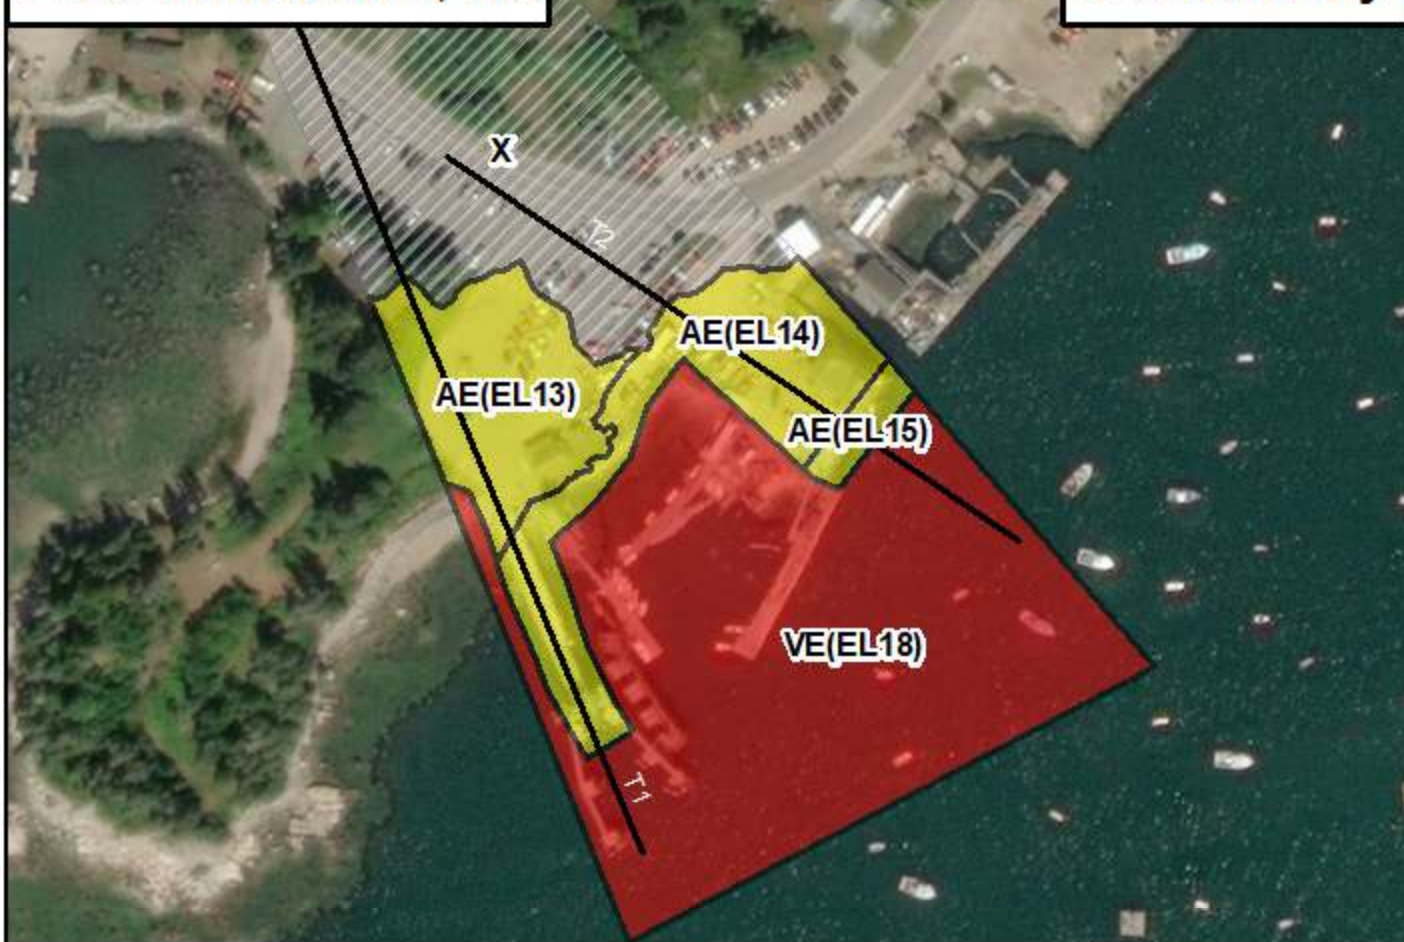
Present Day

Site: Vinalhaven, ME
